PART 2- TECHNICAL REVIEW

1. Fakaofu System Review

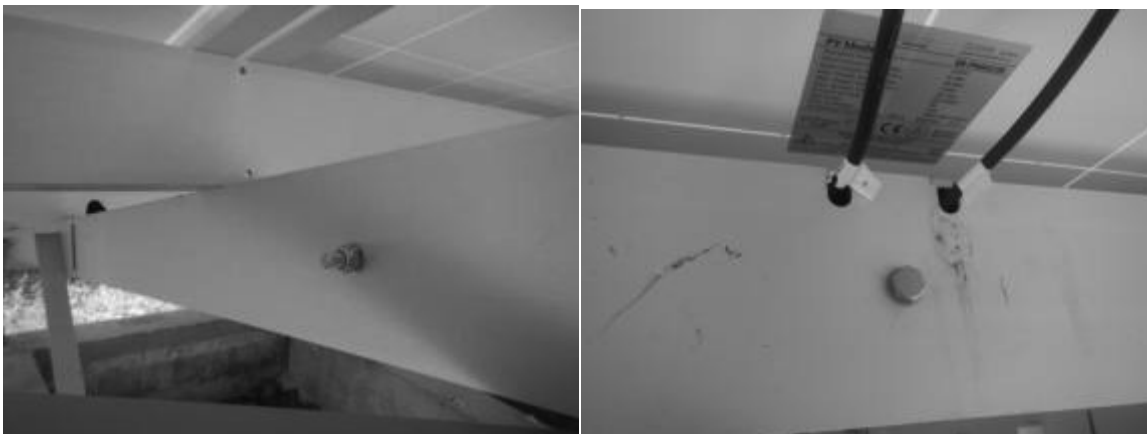
No signs of movement were observed, and none of the bolts randomly checked were loose. Figure 1 and Figure 2 show typical array frame details including bolts and general condition of the array frame. No structural problems were observed. Some small red rust patches were found on the aluminium frames (Figure 1). This is not aluminium rust (aluminium rust is whitish in colour, while iron and steel rust is red) so is likely caused by residue from steel strapping used during transportation. This will not cause corrosion of the aluminium and is therefore cosmetic only.

Figure 1: Array frame detail showing typical bolt (left) and residual rust marks from steel strapping (right)

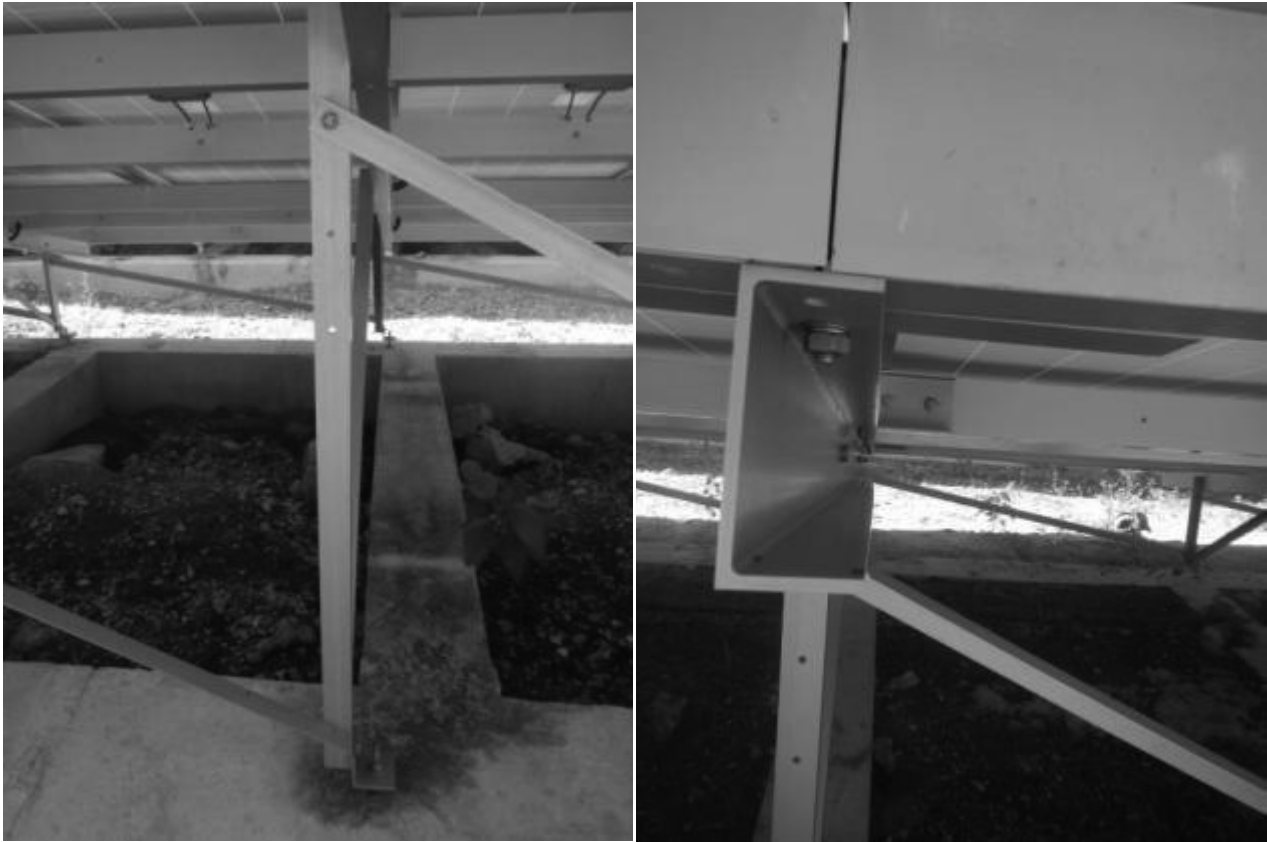
Figure 2: Array frame detail showing general condition of array frame and bolts

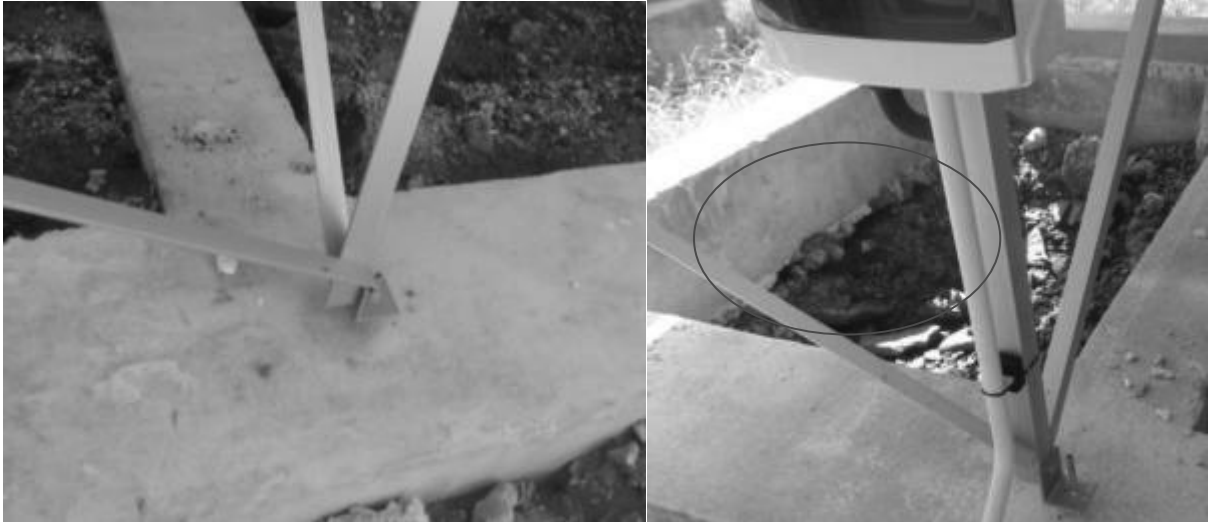
An area of concern at this site is support of the concrete foundations. Half of the array is mounted in swampy ground, so rock, coral and wood have been used to fill in the area under the foundations before pouring the concrete. In some areas, there are preliminary signs of erosion of the soil and rocks supporting the foundations (Figure 3). In other areas, it appears that the foundations are not fully supported by rock underneath – for example, Figure 4 and Figure 5 show parts of the foundation supported by wooden logs that are beginning to rot, and areas where there appears to be no supporting rock under the foundation.

Figure 3: Typical concrete footing detail (left); signs of erosion around foundation (right)

Foundations should be checked regularly for signs of sagging or cracking in areas with minimal support. In particular, wooden logs under the foundation should be replaced with rock support when they have rotted through.

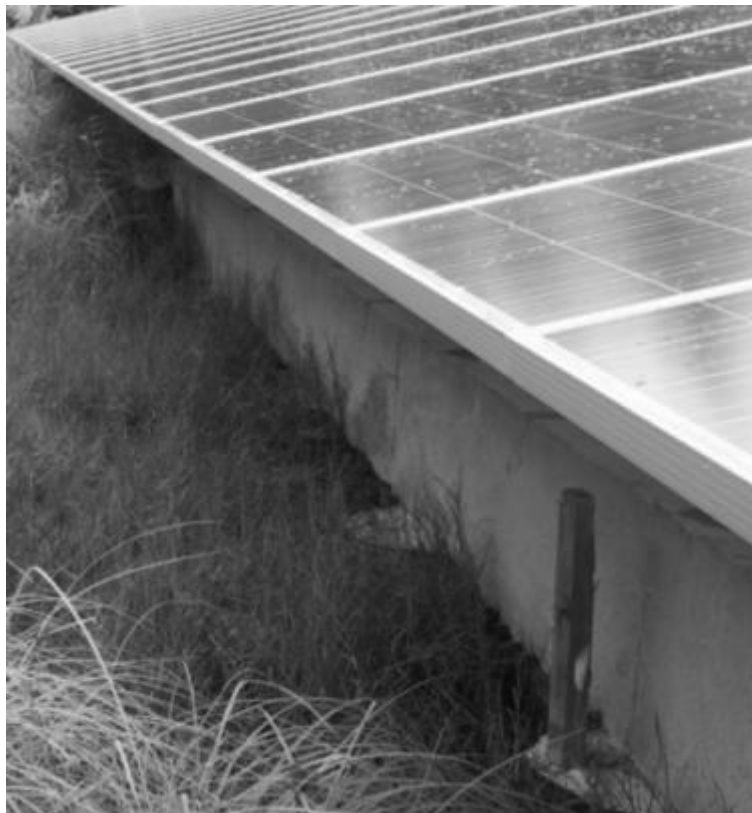
Figure 4: Foundations in swampy ground appear unsupported

1. Some areas of the foundations on the swampy side of the array need to be reinforced by adding rock or crushed coral under the foundations, as the wood used will decay over time.

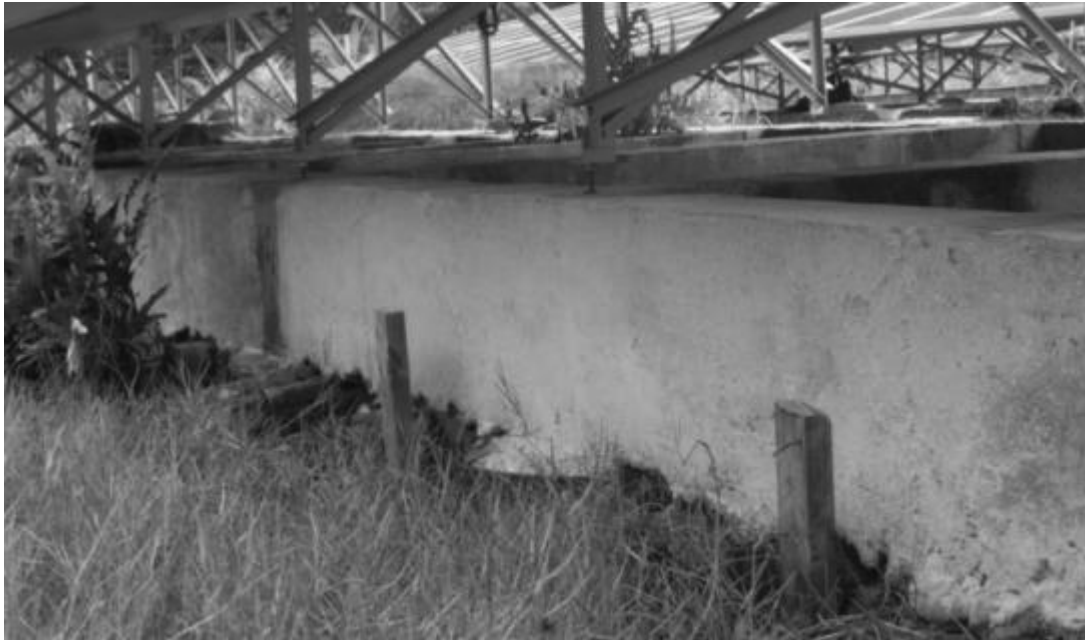
Figure 5: Foundations in swampy ground supported by wooden logs

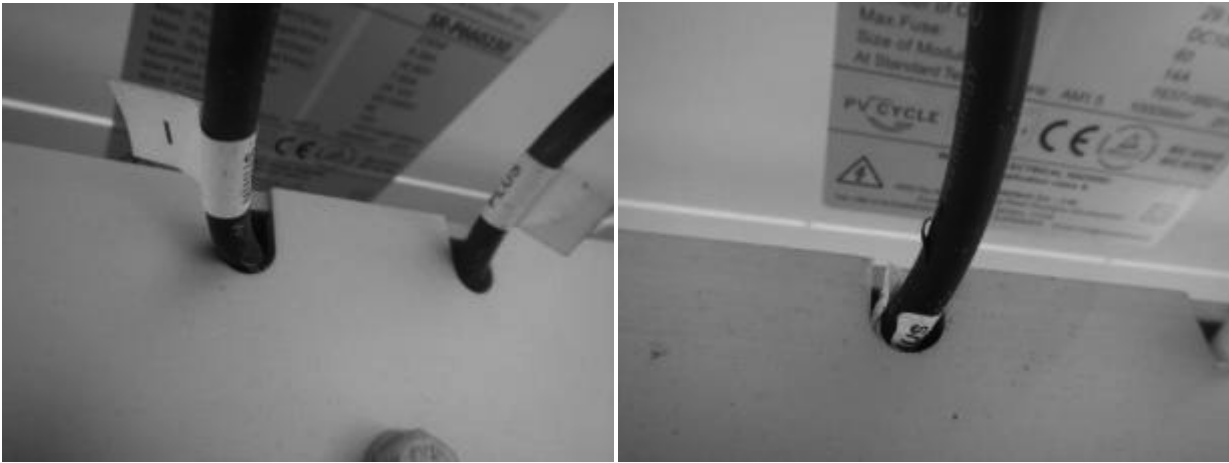
Cable entries to ducting have sharp edge and in some cases the cables were pulled up against these edges (Figure 7). Some scratching on the outer insulation of the cables was observed, but no deep cuts in the insulation were found. Wiggling the cables produced very little movement so it is unlikely that they are rubbing against the edges due to movement. Nonetheless these points on the array should be monitored to ensure that the cable insulation is not damaged over time.

Figure 7: Cable entries to ducting – some scratches visible

No immediate rectification work is required. However, cables entries to the ducting (as shown in Figure 7) should be checked regularly for signs of damage.

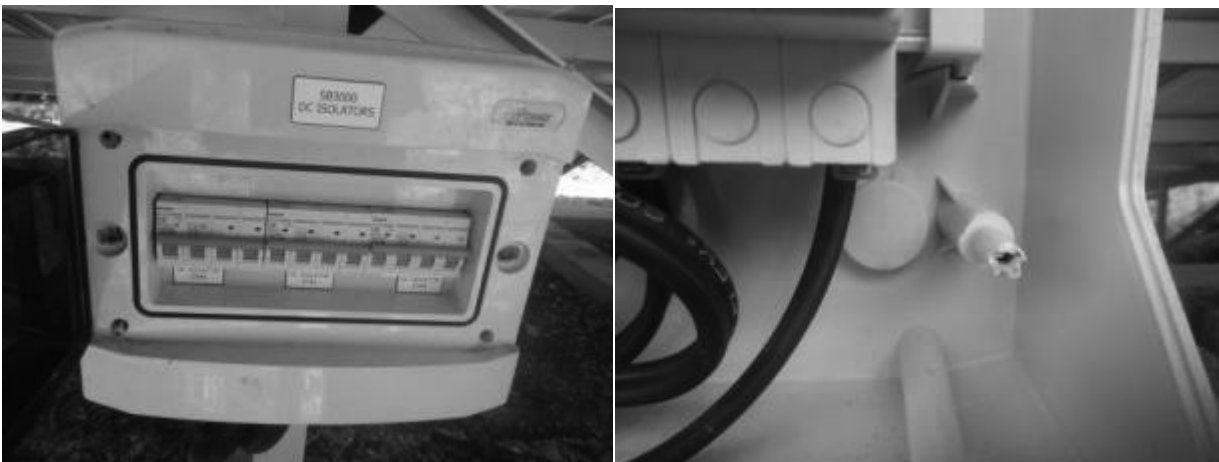
Two isolator enclosures were found needing minor repair – one (in row one) had a burred screw while another (in row five) had a small part missing from the latching mechanism on the cover, preventing the cover from closing correctly. Both these issues were rectified immediately by the local operators.

Screw mounts inside the isolators are showing some signs of wear (Figure 9) indicating that they may need replacing after several years of opening and closing the isolators.

Figure 9: Isolator with damaged screw (left) and signs of wear on screw mounts (right)

Screw mounts are showing some signs of wear and may deteriorate after several years of opening the isolator enclosures. Staff should ensure that spares are available should they be required.

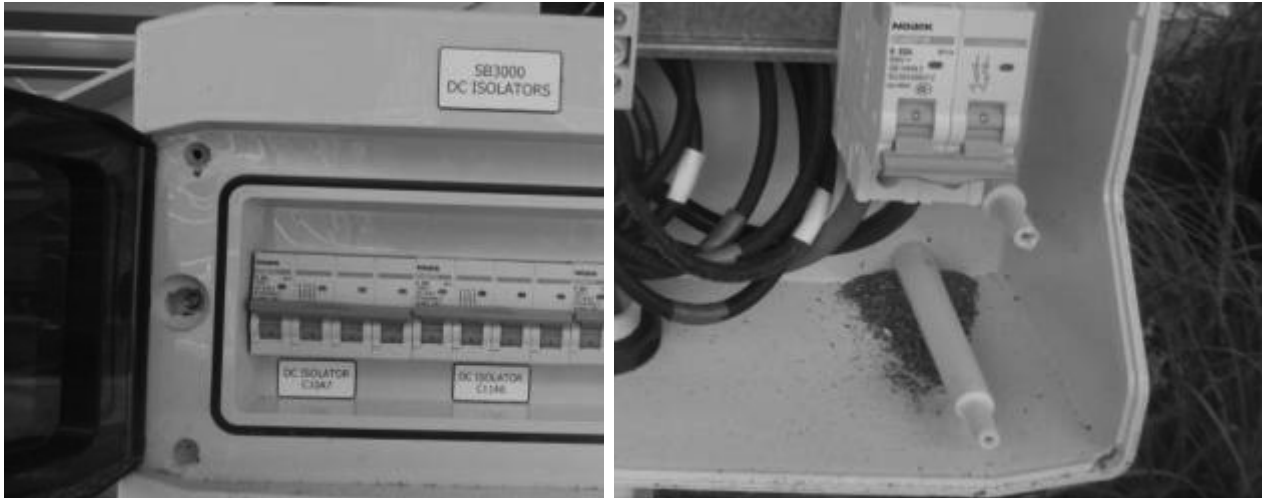
A few isolator enclosures had wasps nesting in the screw holes (Figure 10) and one isolator showed signs of previous ant infestation. The infestation was not widespread and wasp nests were easily removed with a screwdriver. There was no evidence that wasp nests would prevent operators being able to open the enclosures if needed. While there is little the operators can do to prevent infestation from wasps or ants, regular removal will prevent excessive build up of debris that could make it difficult to open the enclosures.

Figure 10: Wasp nests in screw holes (left); evidence of ants inside isolator (right)

2. Check array isolators for wasp nests regularly and remove them to avoid excessive build up.
3. The temperature in the inverter room is excessive and needs to be reduced. Larger, more robust extractor fans are needed. An air conditioner can also be considered, though this would need to be supplemented with fans so that a failure of the air conditioner would not cause the room to overheat.

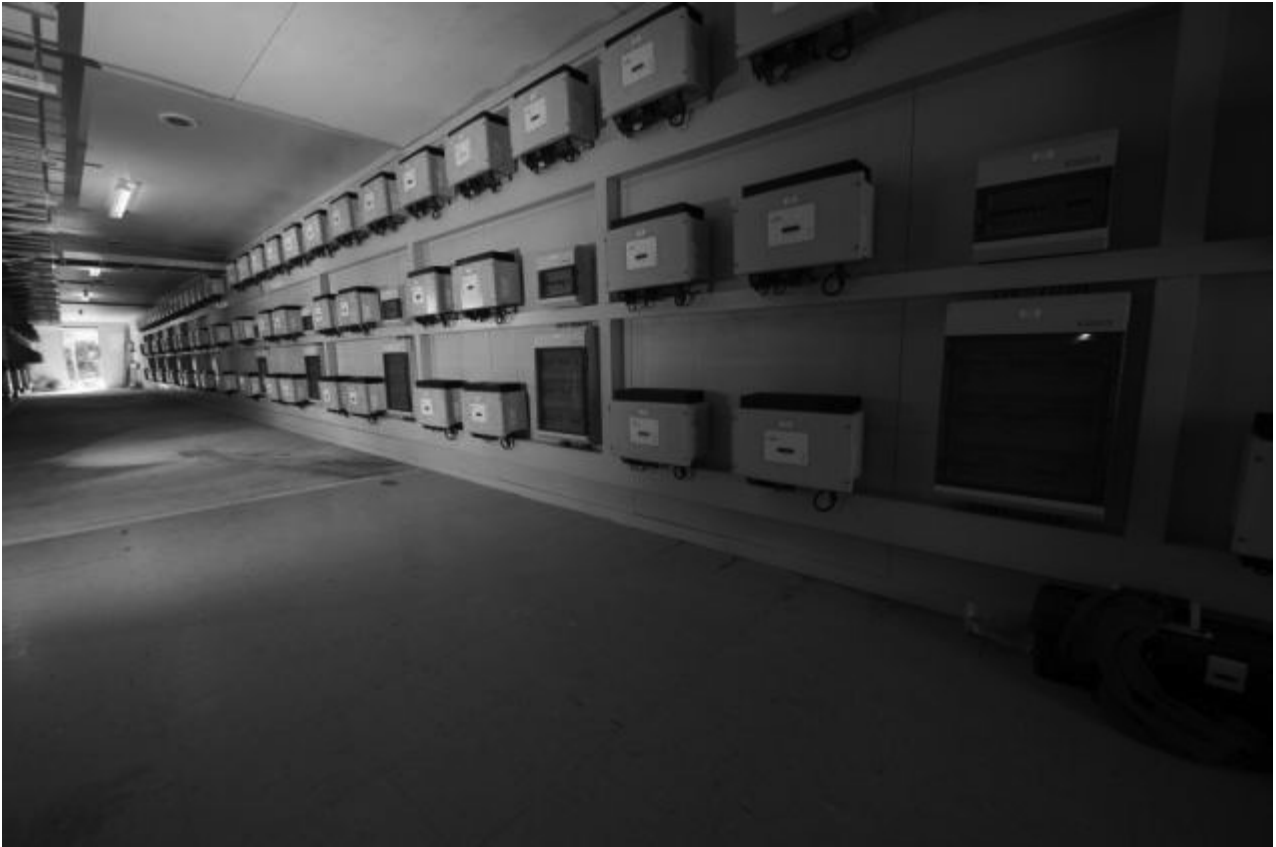
Temperature measurements ranged from 42°C near the door to 45°C in the middle of the room. A measurement taken above an inverter heat sink read 49°C. Ambient temperature (outside in semi-shade) was 32°C. These temperatures are excessive and indicate that the existing ventilation is not adequate. Inverters will suffer both a performance loss and a shortened lifetime if kept in a consistently hot environment.

Figure 12: Inverter wall and extractor fans visible in ceiling

The inverter room temperature is excessive and should be reduced. The existing extractor fans are ineffective and two of four do not appear to be operational. Extractor fans should be replaced with larger fans or an air conditioner.

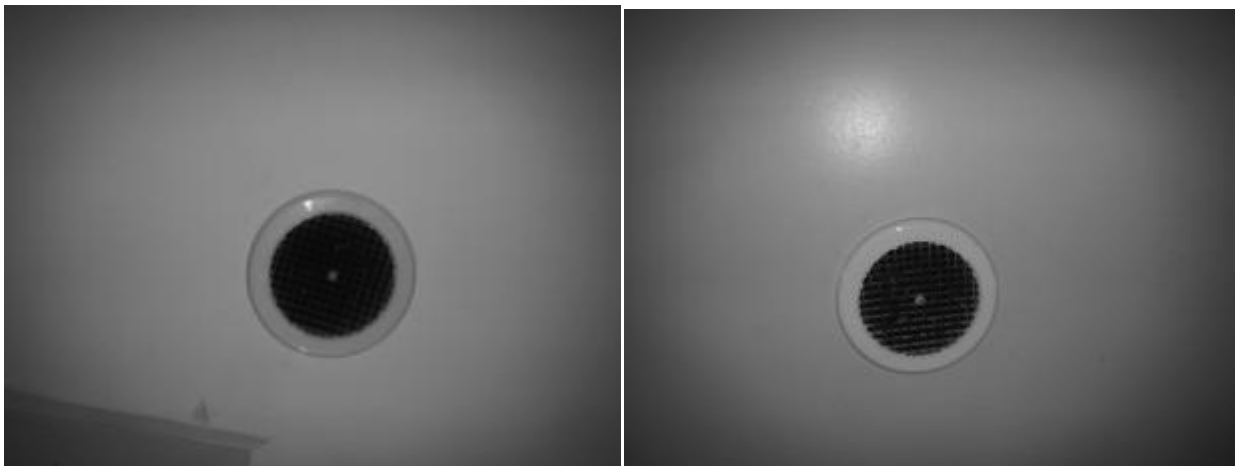
Extractor fans appeared dirty (Figure 13) and may be clogged internally. Only two of four fans were operating at the time of the inspection. ITP recommends that significantly larger fans are installed as the current ventilation scheme is inadequate.

Figure 13: Extractor fans in the centre of the inverter room

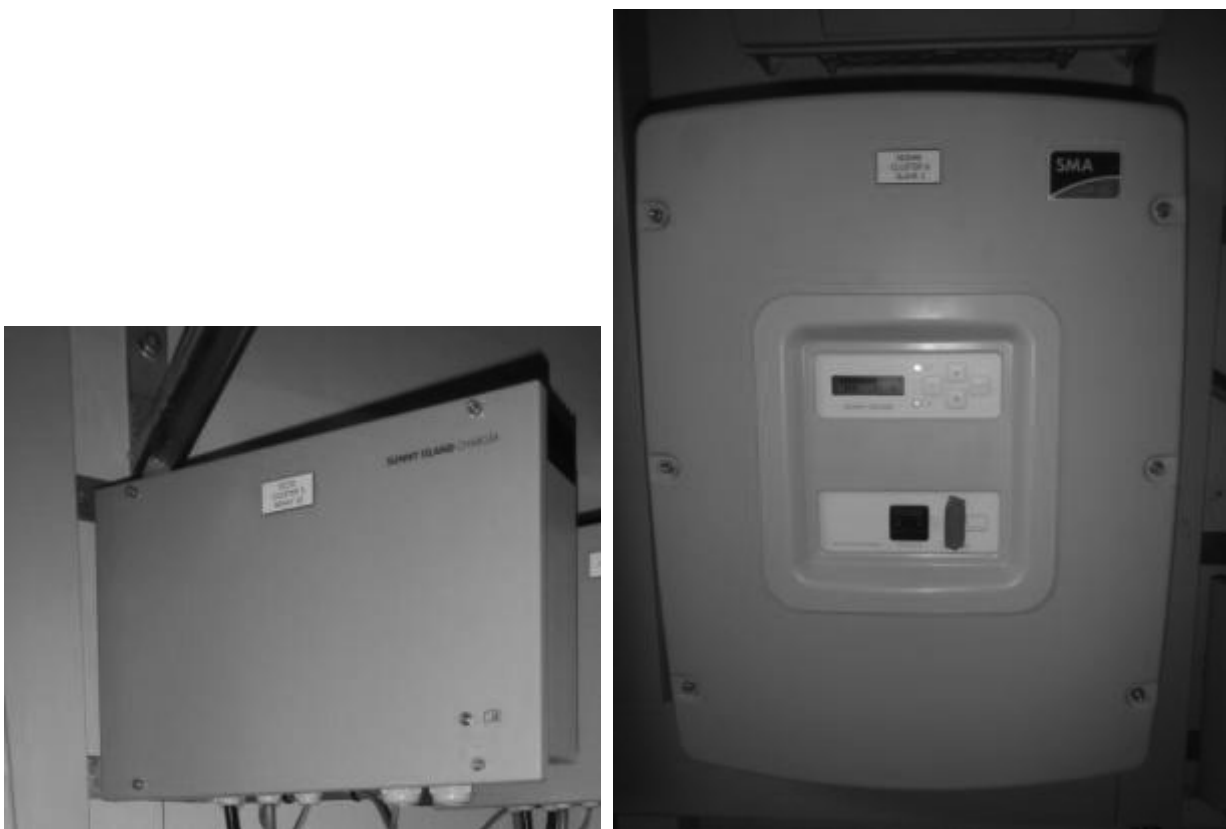
All inverters, Sunny Islands and chargers were operating normally at the time of the inspection. Two Sunny Islands (Cluster 4 Slave 1 and Cluster 6 Slave 2) were missing SD cards. This does not affect data gathering capability as Master 4 and Master 6 were both equipped with SD cards and will collect data from the slaves. Nonetheless, SD cards should be provided for these slave units at the next available opportunity. Three of the chargers (C5A9, C3A10 and C3A9) had indicators lights not functioning but the Sunny Islands indicated that batteries were charging normally. We were advised by the operators that there had been some problems with the indicator lights and that this was being investigated by SMA.

Figure 14: Charger with faulty indicator light (left) and Sunny Island missing SD card (right)

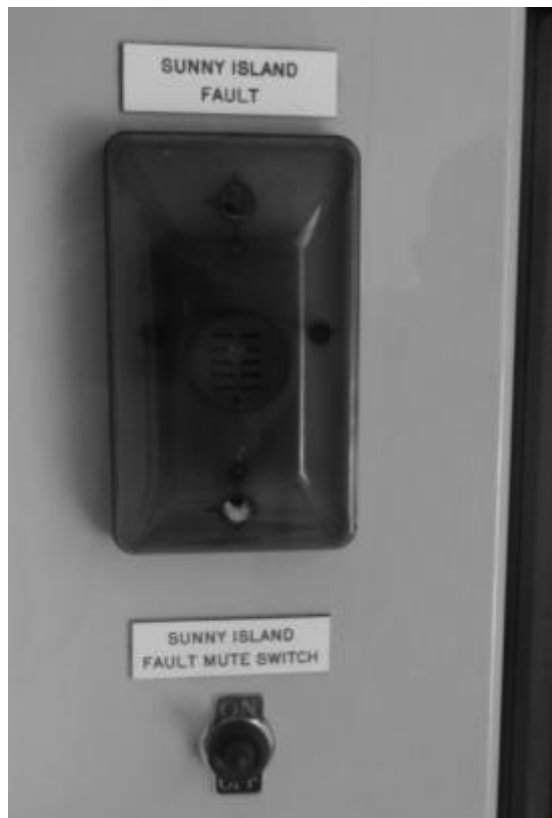
Operators reported no erroneous tripping. However, the Sunny Island Fault Mute Switch was in the “ON” position. This may indicate that erroneous tripping has occurred and that the audible alarm has been muted, or that it was switched to “MUTE” during testing and maintenance (which took place in April 2013) and has not been switched back off.

Figure 15: Sunny Island Fault Mute Switch is on

Fault Mute Switch should be kept in the “OFF” position at all times except during testing and maintenance. Leaving the alarm on mute could result in operators missing genuine alarms.

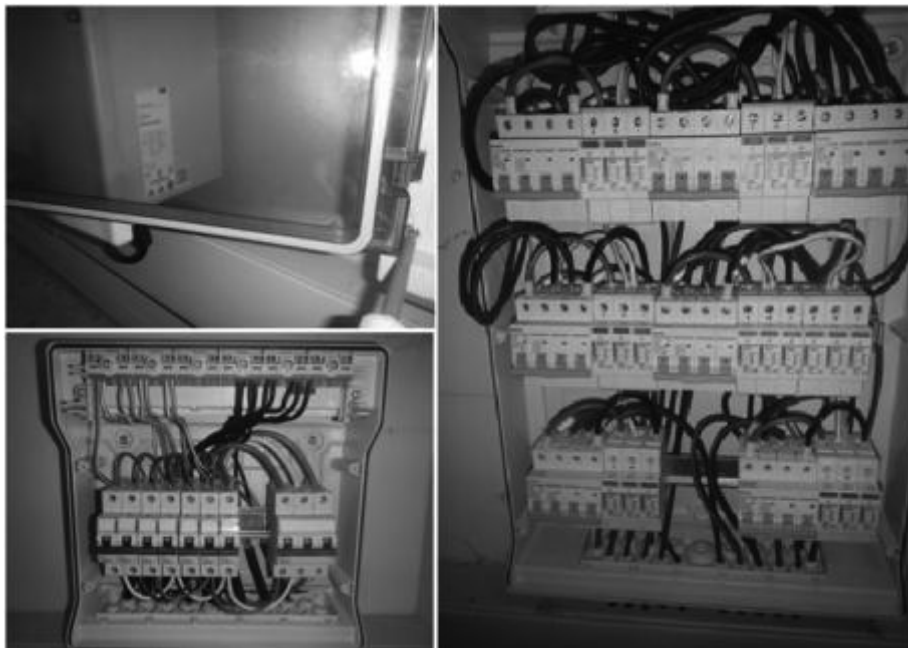
While opening the isolator enclosures we noted that the lids are obstructed by the Sunny Boys next to them (see Figure 19 top right) which prevents them from being fully opened. This makes it slightly difficult to access the screw to remove the isolator lid, so operators will need to take care not to damage the lid when undertaking maintenance.

Figure 19: Removing enclosure lid (top left), wiring inside AC enclosure (bottom left) and inside DC enclosure (right)

Note that operators should take care not to damage enclosure lids when opening the enclosures. Ideally, the layout of the equipment should be such that the lids are not obstructed by other equipment such as Sunny Boys.

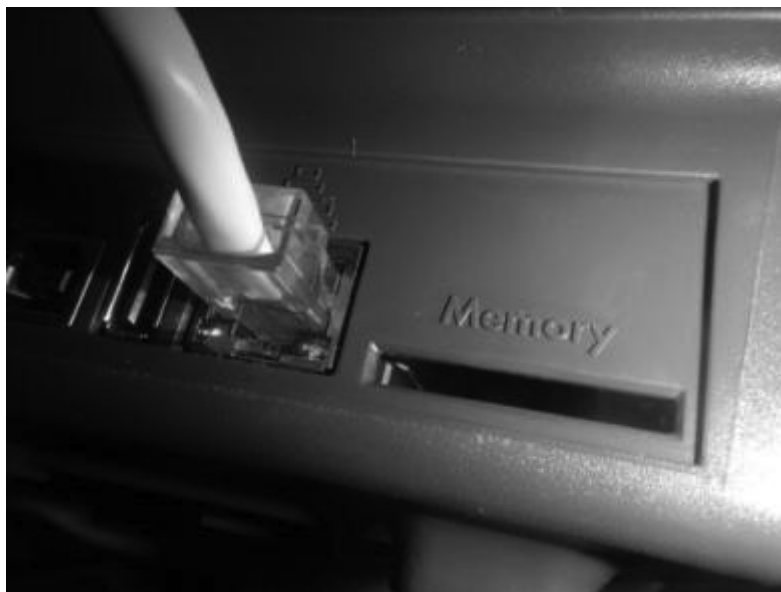
Two of three Webboxes (top two shown in Figure 20) were missing SD cards and they could not be found anywhere nearby. The SD cards store data regularly and can be used as a backup to access data when the internet connection fails. As the SD cards are missing, there may be data lost for some days when the internet connectivity was down. We had spare SD cards on hand and left new 2GB SD cards in the two Webboxes that were missing cards.

As the system was commissioned with SD cards in all Webboxes, there may be an issue with local operators taking the SD cards for their own use. It is unlikely that an unauthorized person could have taken them, as such a person would be unlikely know where to find the SD cards or have the tools to open the enclosure.

Figure 21: SD cards missing from Webboxes

No remedial work is required. As the SD cards appear to have gone missing, the Director of Energy should investigate the issue of local operators taking SD cards off site.

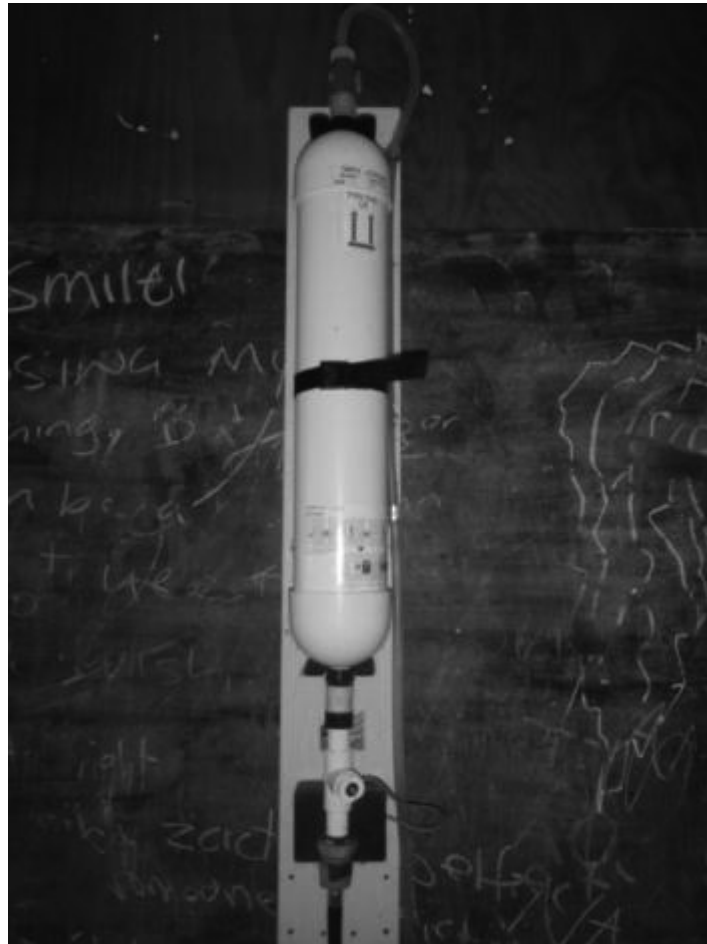
A deionizer was mounted on the wall in the battery room. The deionizer light was flashing (indicating that the filter needs replacing). However, the operators believed that the battery needed changing as the deionizer had only been used twice since system commissioning. They reported that they had a spare filter in the store room but that they would try replacing the batteries first.

Figure 23: Deionizer mounted on wall in battery room

The batteries in the deionizer should be changed and the indicator light should be checked again. If it is still flashing, the filter should be replaced and a spare one ordered.

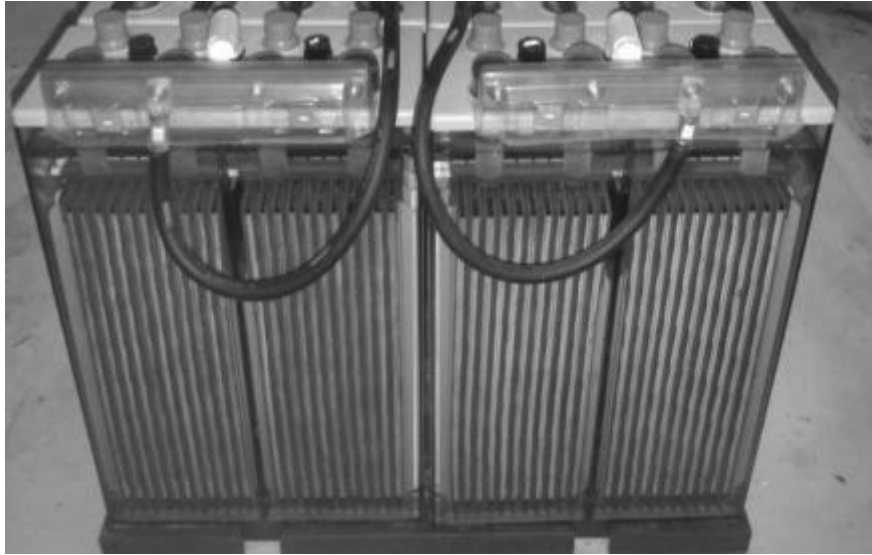
No signs of sulfation were observed. Battery water levels were all close to the maximum level. Small lead deposits (up to 5mm deep) could be seen in the bottom of the batteries. These were not considered excessive. No signs of physical damage were observed and all terminals were insulated.

Figure 24: Battery plates and small lead deposits in bottom of batteries

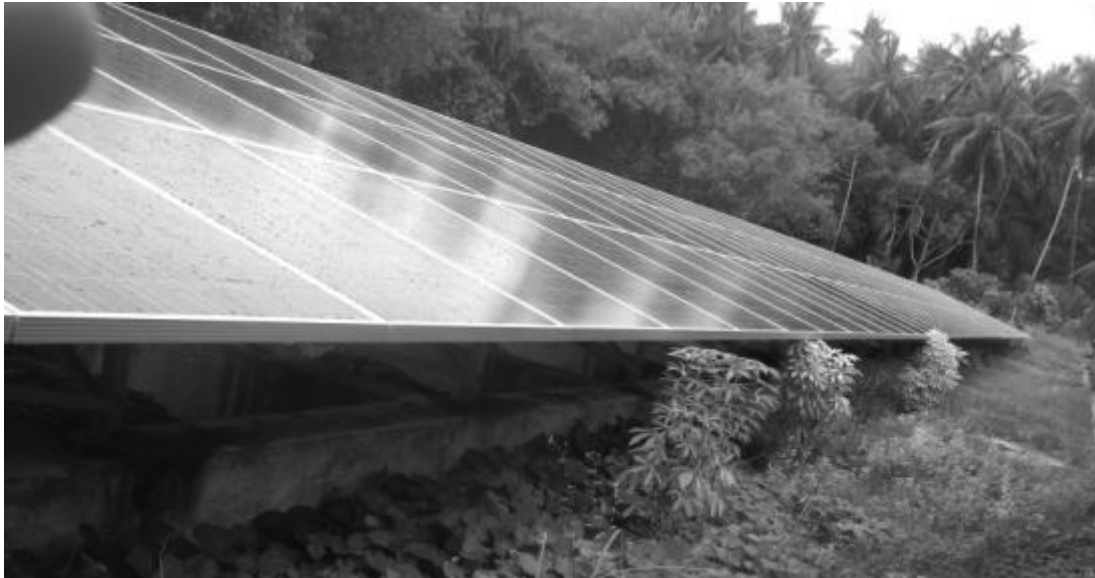
In one row at the western end of the array, there were plants grown from cuttings which had been deliberately planted indicating that there was unauthorized access to the site. This likely occurred before the fence was built so is not expected to be an ongoing problem.

Figure 30: Crops planted in front of the array

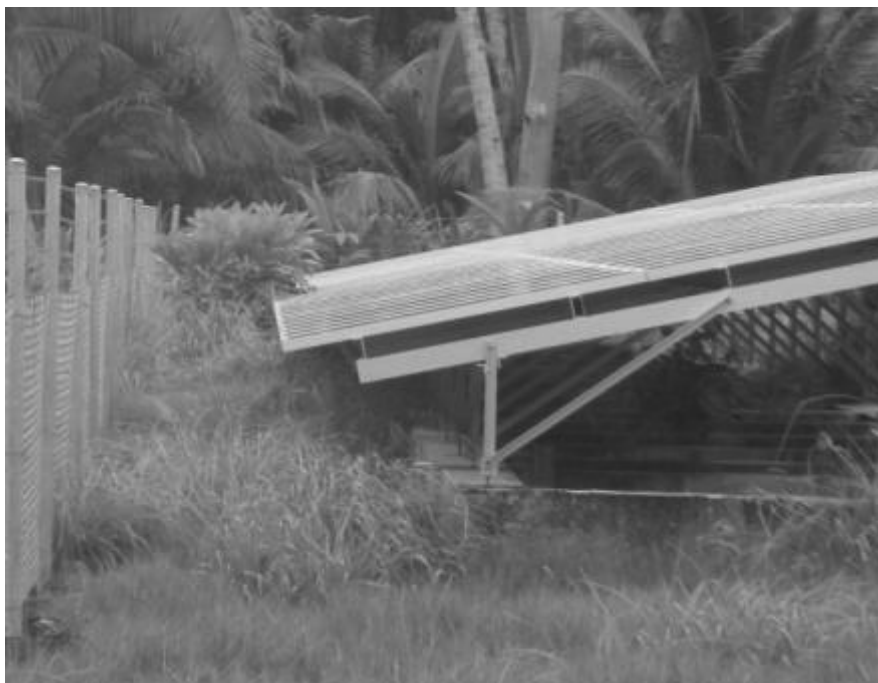
Figure 31: Plant shading the array. Overgrown vegetation in this area makes it difficult to access the eastern end of the array

8. Vegetation around the array was very overgrown and needs to be cut back.
9. It is desirable, though not crucial, to repair a second diesel generator for redundancy in times of bad weather or when the PV system needs to be shut down for maintenance.

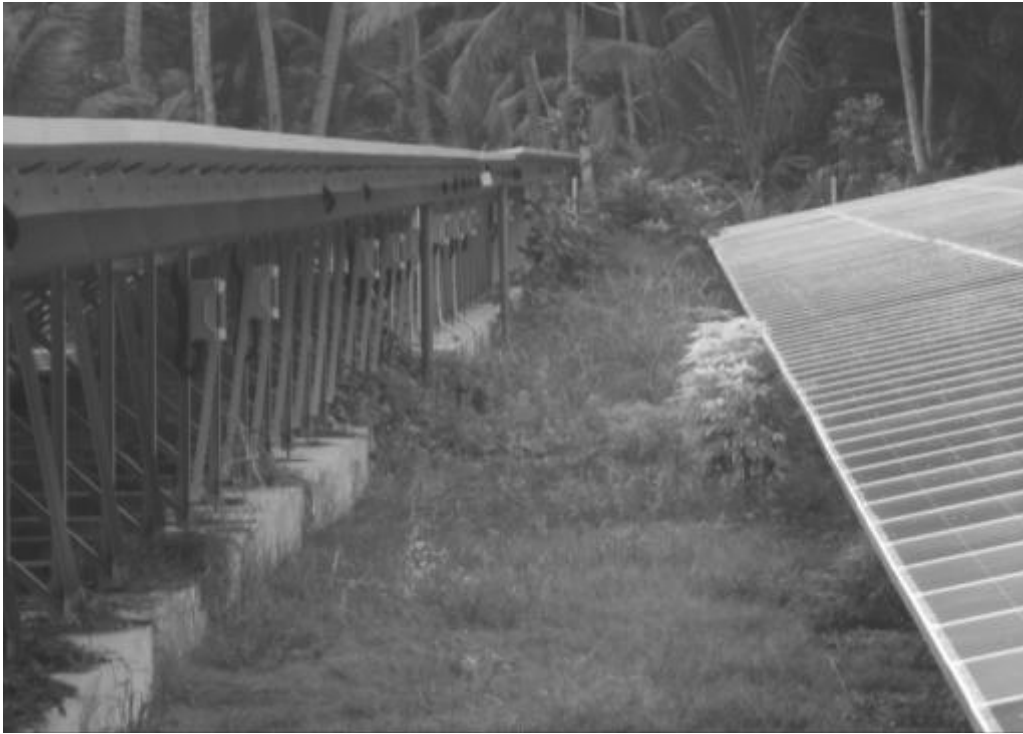
Figure 32: Excessive vegetation around array including plants shading panels and creepers on framing

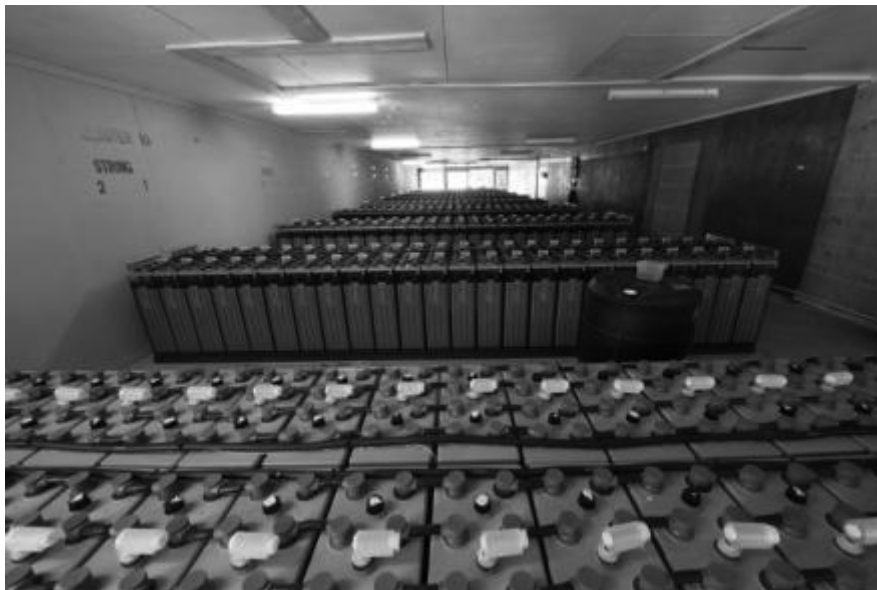
The battery room was generally clean and dry. One drum of battery acid had been left next to the batteries. Because of the size of the room this does not greatly obstruct access, but the drum should nonetheless be moved out of the way.

Figure 35 Drum of battery acid next to batteries

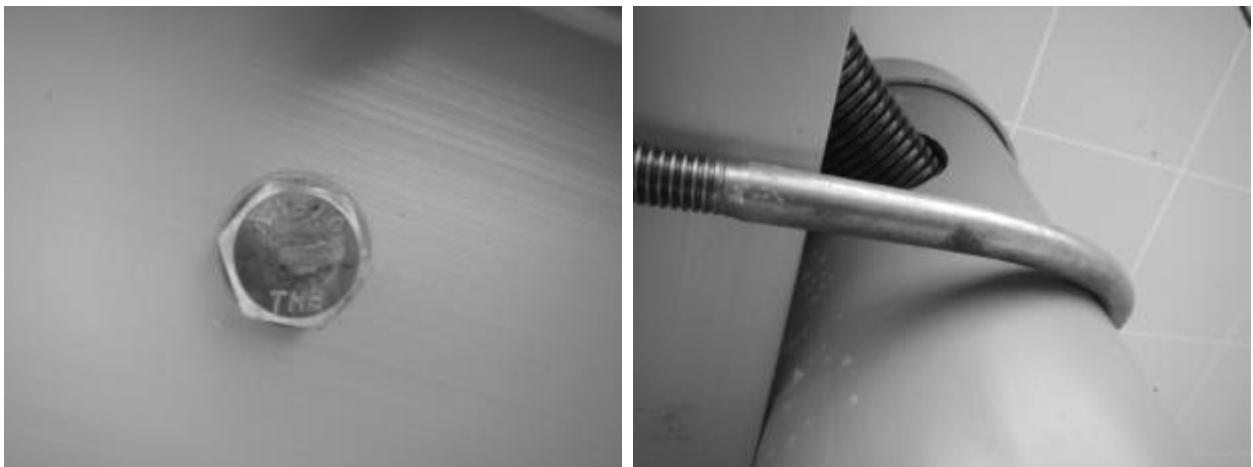
No signs of movement were observed, and none of the bolts randomly checked were loose. Figure 38 and Figure 40 show typical array frame details including bolts and general condition of the array frame. No structural problems were observed. Some small spot rust (“tea staining”) was observed on some of the bolts and small rust patches were found on the u-shackles used to support PVC conduit containing cables. Tea staining on stainless steel usually occurs around joints or edges (such as the lettering on the bolt shown) and is mainly a cosmetic issue unlikely to spread. Nonetheless, bolts should be checked regularly for any signs of more extensive rust. Rust spots on the u-shackles should also be checked regularly and these may need to be sprayed with an anti-rusting agent.

Figure 38: “Tea staining” on bolts (left) and small rust patches on u-shackles

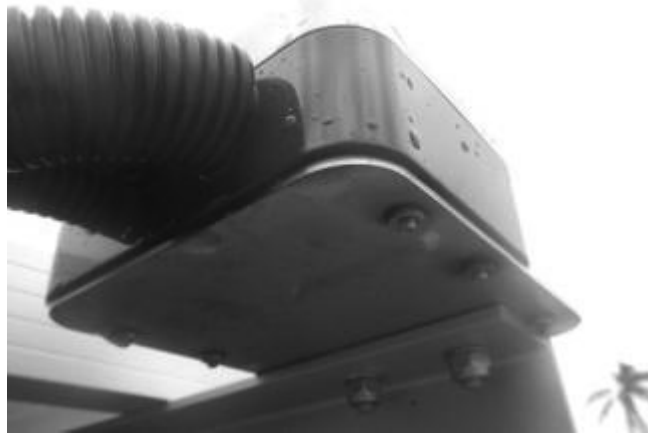
Small rusted bolts were also found on the SMA sensor module attached to the array. These screws may need to be replaced. However this is not a structural problem.

Figure 39: Rusted bolts on SMA sensor module

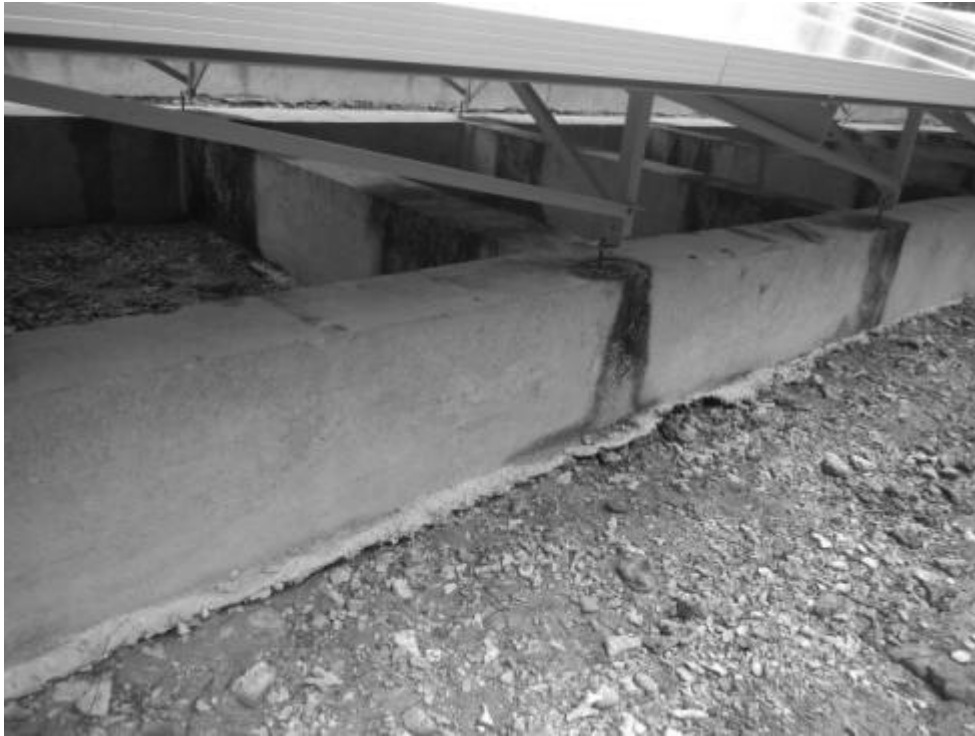
Visual inspection of concrete footings revealed no cracking or crumbling of concrete around the array mounting points. There were some preliminary signs of soil erosion around the footings that should be monitored.

Figure 41: Concrete footings showing some preliminary erosion of soil

The array structure should be checked periodically by local staff for any signs of movement or loose bolts or further erosion around the footings.

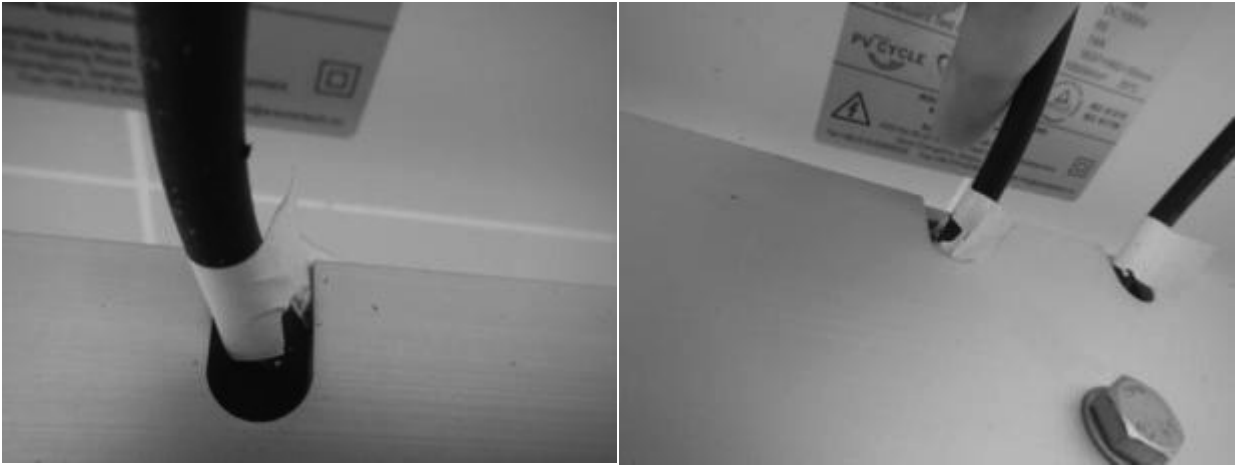
Cable entries to ducting have sharp edge and in some cases the cables were pulled up against these edges (Figure 43). Some scratching on the outer insulation of the cables was observed, but no deep cuts in the insulation were found. Wiggling the cables produced very little movement so it is unlikely that they are rubbing against the edges due to movement. Nonetheless these points on the array should be monitored to ensure that the cable insulation is not damaged over time.

Figure 43: Cable entries to ducting – some scratches visible

No immediate rectification work is required. However, cables entries to the ducting (as shown in Figure 43 and Figure 44) should be checked regularly for signs of damage.

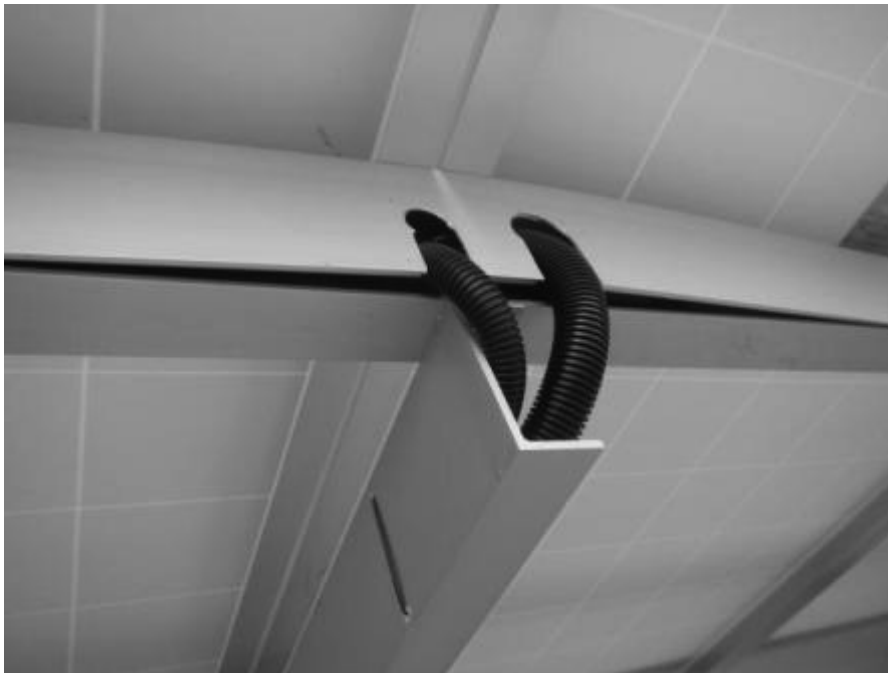
Exposed conduit (Figure 44Figure 8) was in good condition and suitably tied up to prevent accidental damage from movement. In two areas (eg Figure 44) the ducting did not sit flush indicating that the cable bend was tight, but this has no significant effect on the conduit.

Figure 44 Conduit entry to ducting

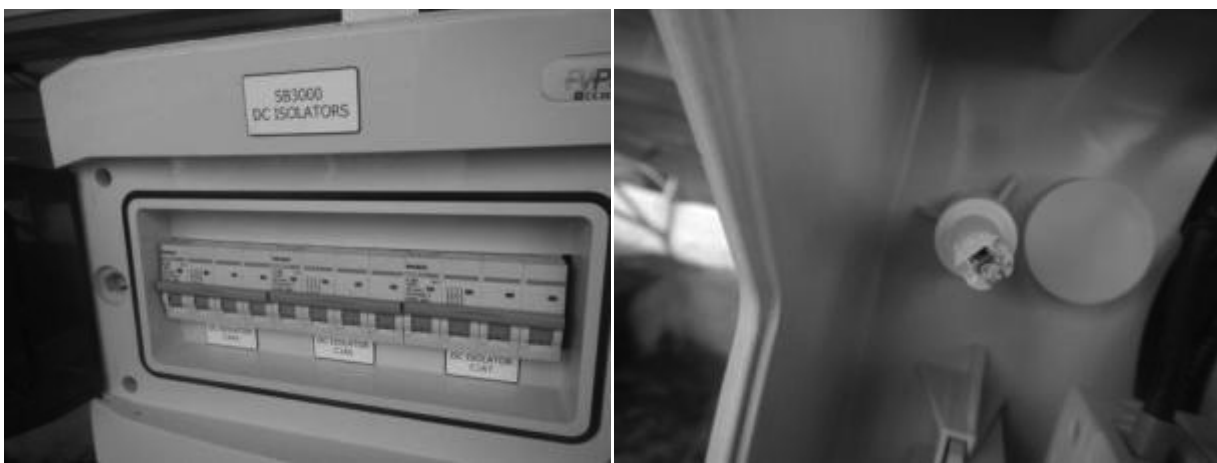
Screw mounts inside the isolators are showing some signs of wear (Figure 45) indicating that they may need replacing after several years of opening and closing the isolators.

Figure 45: Isolator labelling (left) and screw mount (right)
