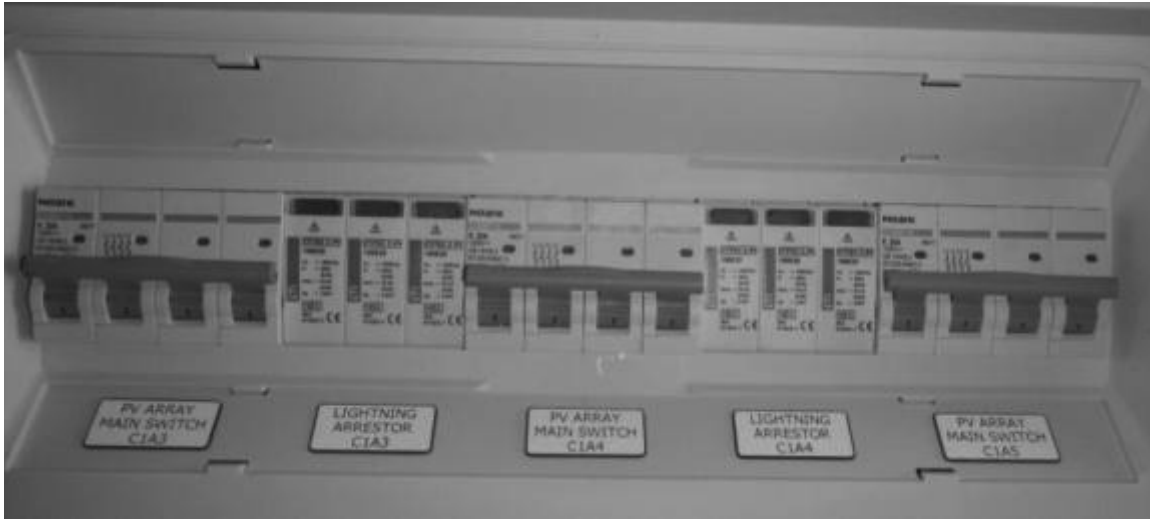
**Figure 52: Sunny Boy lightning arrestors intact (red button pops out when tripped)**

All Sunny Boy lightning arrestors were intact (for these arrestors a red button pops out when the arrestor is tripped).

No action is required.

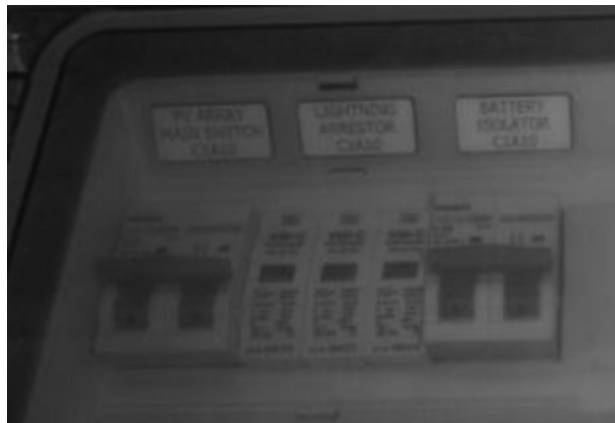
**Figure 53: Lightning arrestors flagged green**

Despite a recent lightning strike, all lightning arrestors were intact. It appears that only the communications cabling was affected by the lightning.

All Sunny Island lightning arrestors were flagged green indicating they were operating normally and had not tripped.

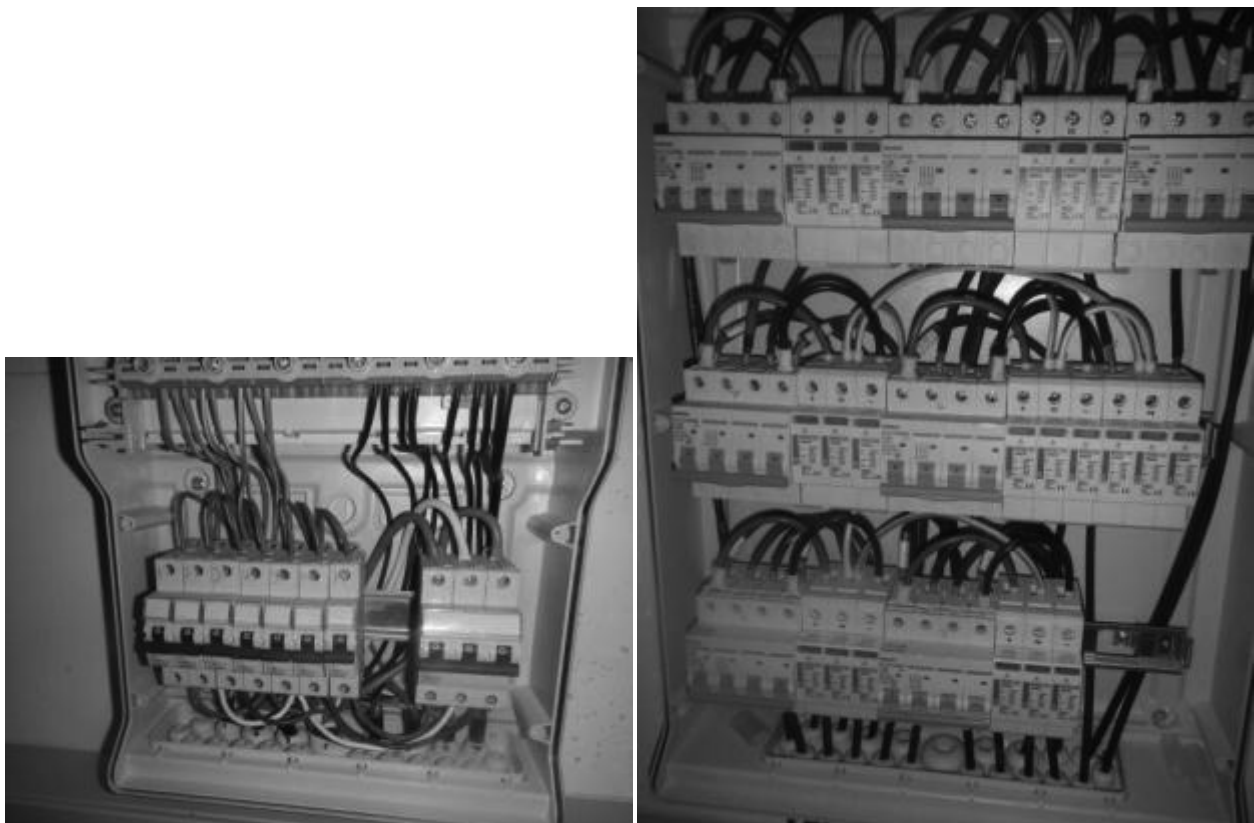
All cables were found in good condition and no loose connections were found.

**Figure 54: AC isolator enclosure wiring (left) and DC wiring (right)**

No action is required.

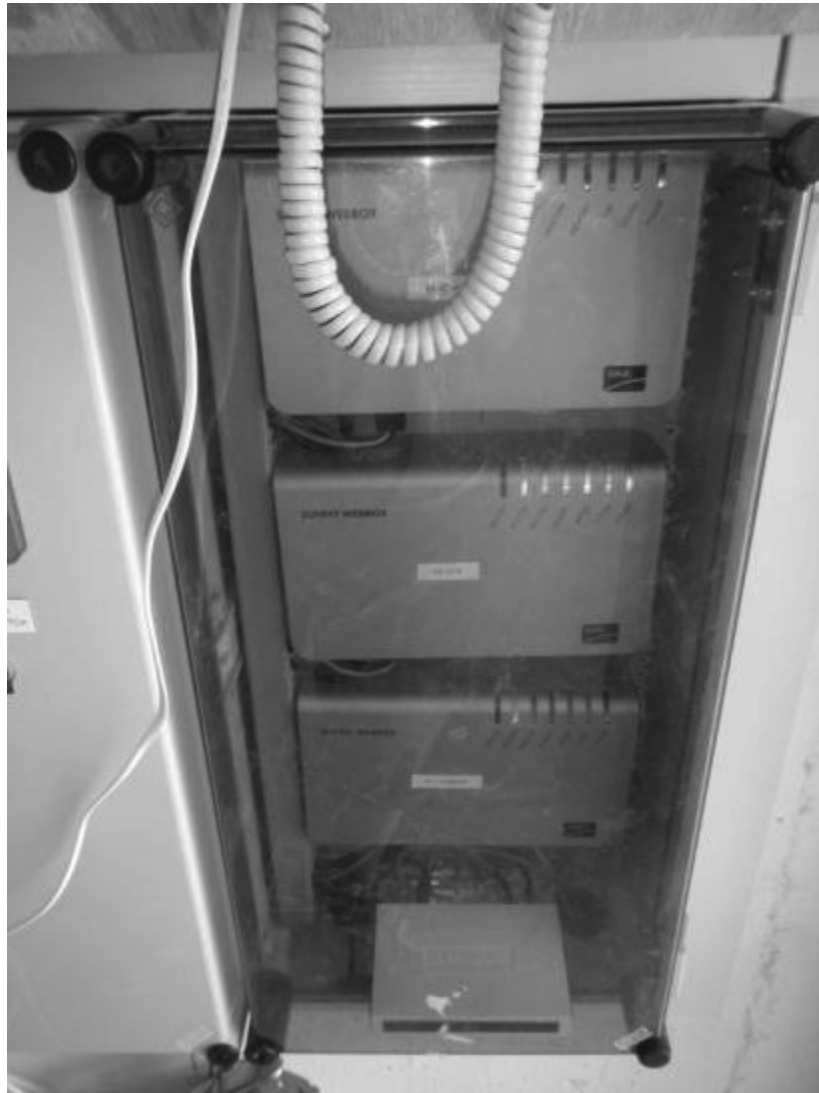
At the time of the inspection, all internet wiring was intact and undamaged. However the Webboxes were offline (indicated by the red light for “NETCOM” in Figure 55). This appeared to be due to a Teletok outage. Internal communications between the Sunny Islands and Webboxes were operating normally. The Webboxes all contained SD cards that were successfully logging data.

**Figure 55: Webboxes have no internet connectivity (red light)**

The system operators reported occasional internet outages caused by Teletok (the internet provider) being down. The system reportedly came back online once Teletok restored connectivity. They were not aware of any internet connectivity problems occurring internally.

Internet connectivity needed to be restored, but this appeared to be a Teletok issue. Operators need to request that Teletok restore the connection.

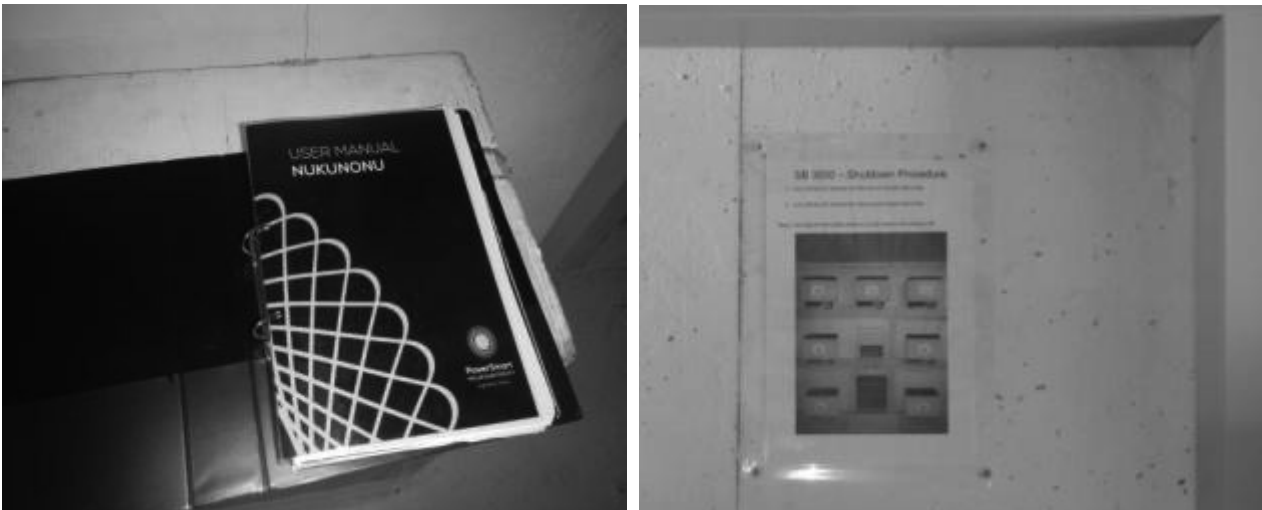
The complete system manual was located in the powerhouse. A check of the system manual showed it was complete. A laminated system diagram was located on top of a cupboard.

Shutdown procedures were mounted in several locations throughout the room.

**Figure 56: Manual and shutdown procedures**

The system diagram should be placed on a wall where it can be easily seen.

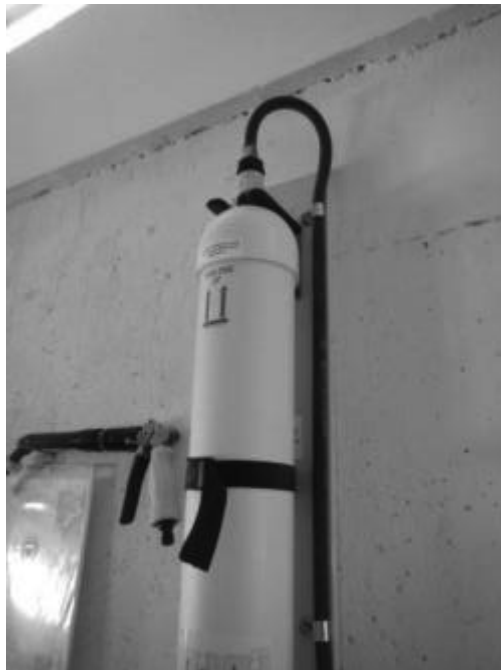
A deionizer was mounted on the wall in the battery room. The indicator light was green indicating that the unit is operating normally. Operators said they had a spare filter should one be required.

**Figure 57: Deionizer in battery room**

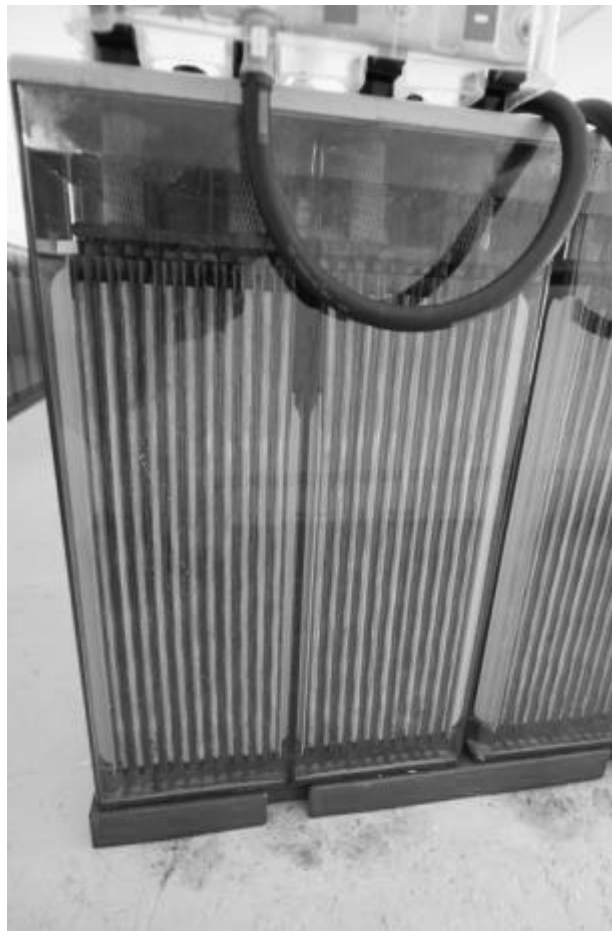
No signs of sulfation were observed. Battery water levels were all close to the maximum level. Small lead deposits (up to 5mm deep) could be seen in the bottom of the batteries. These were not considered excessive. No signs of physical damage were observed and all terminals were insulated.

**Figure 58: Battery plates and small lead deposits at bottom**

Other than routine maintenance, no further action is required.

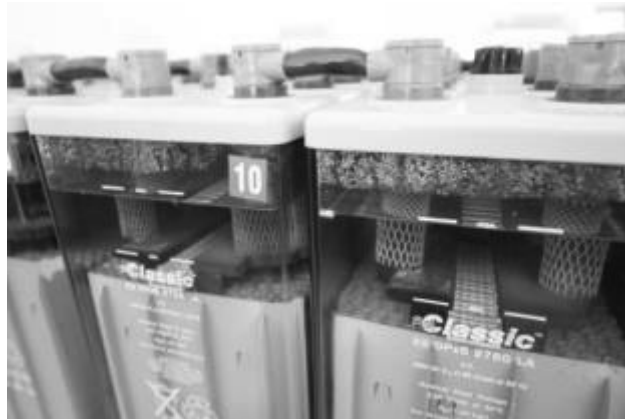
**Figure 59: Battery water levels close to maximum line**

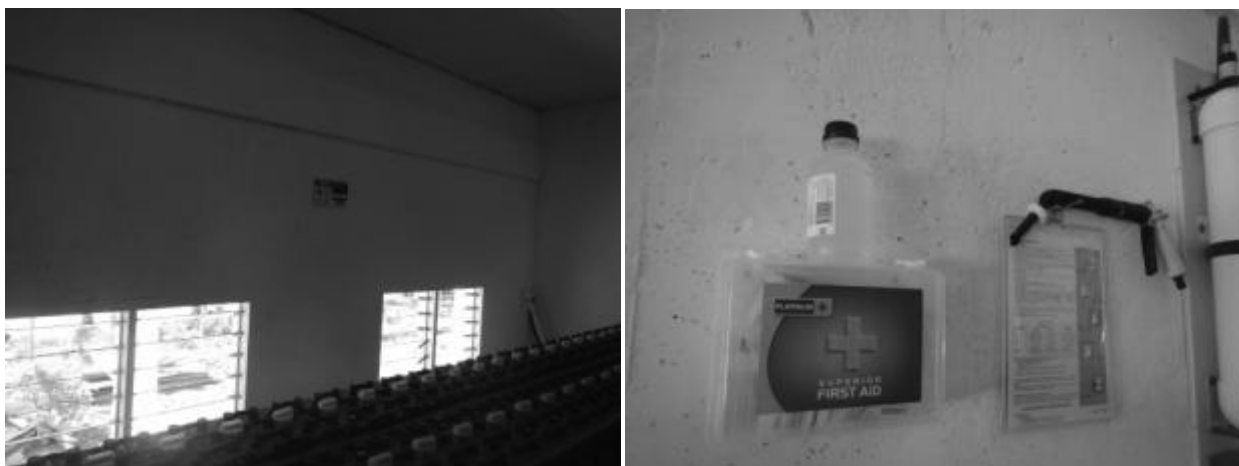
Appropriate warning labels were mounted on the walls at both ends of the battery room. Each battery was numbered, however there were no string numbers painted on the wall as there were at Fakaofu.

**Figure 60: Battery room warning labels**

It would be useful to label battery clusters and strings with signs on the wall. However this is not crucial.

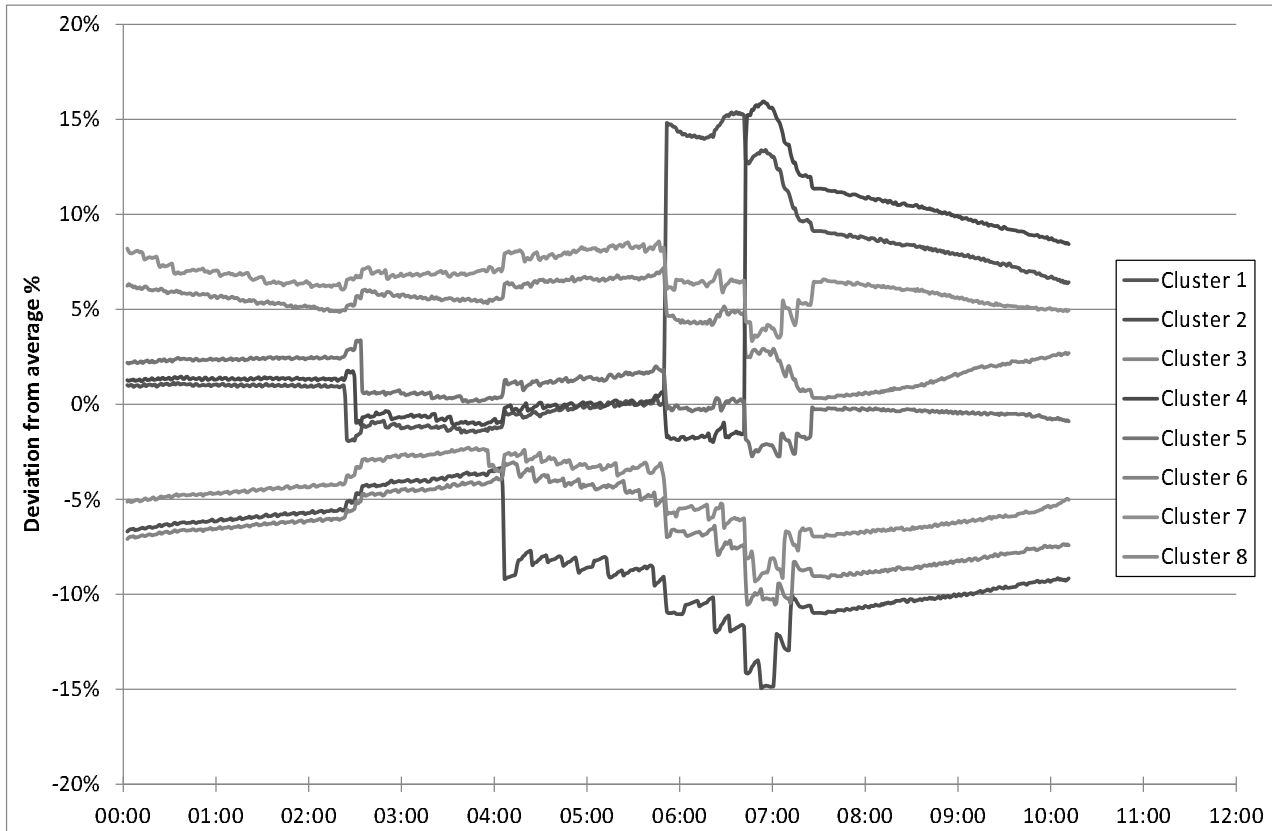
SOC data from the Sunny Islands was used to compare SOC across individual battery clusters. Each cluster was compared with the average SOC to find the deviation from the average throughout the day. Figure 61 shows the deviation from the average of each cluster. Note that sharp drops noticeable in the graph are a result of the Sunny Island's algorithm and do not reflect sudden actual drops in SOC. There is considerable variation across the clusters of up to +/-15%, though this varies when the algorithm recalculates. There may also be variation from clusters discharging to equalize other clusters. Cluster 5 appears low throughout the day, but this may not be a concern unless it is found to be consistently lower than other clusters over time.

**Figure 61: Battery cluster percentage deviation from average SOC (05 June 2013)**

The large step changes in SOC may indicate that the Sunny Islands' method of calculating SOC may be problematic, and may make it more difficult to identify battery problems.

There is some deviation in the battery SOC across battery banks although some of the variation may be accounted for by the Sunny Islands readjusting their SOC calculation algorithm. The batteries should be monitored carefully and checked to make sure that one bank is not consistently different from others.

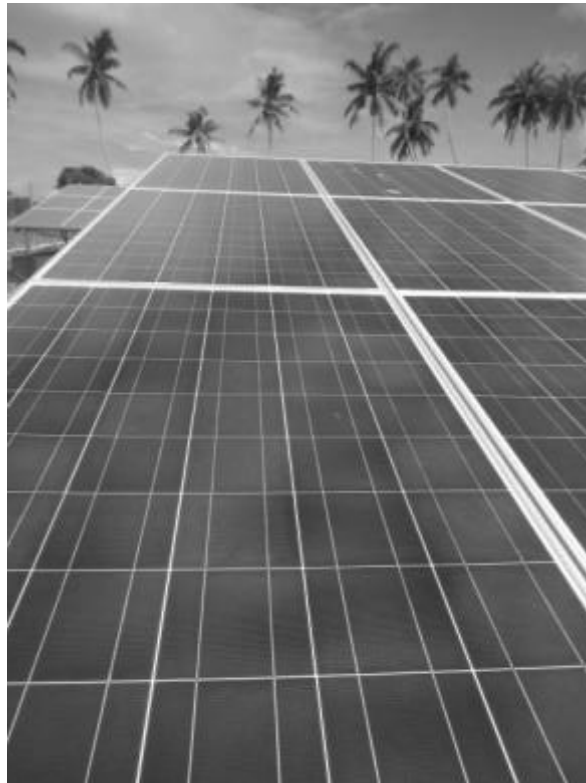
Overall the panels were clean and free from any signs of excessive build up of dirt or droppings. There were some bird droppings on the panels but these were not excessively stubborn and appear to wash off in rain storms.

**Figure 62: Panels generally clean, some bird droppings at top**

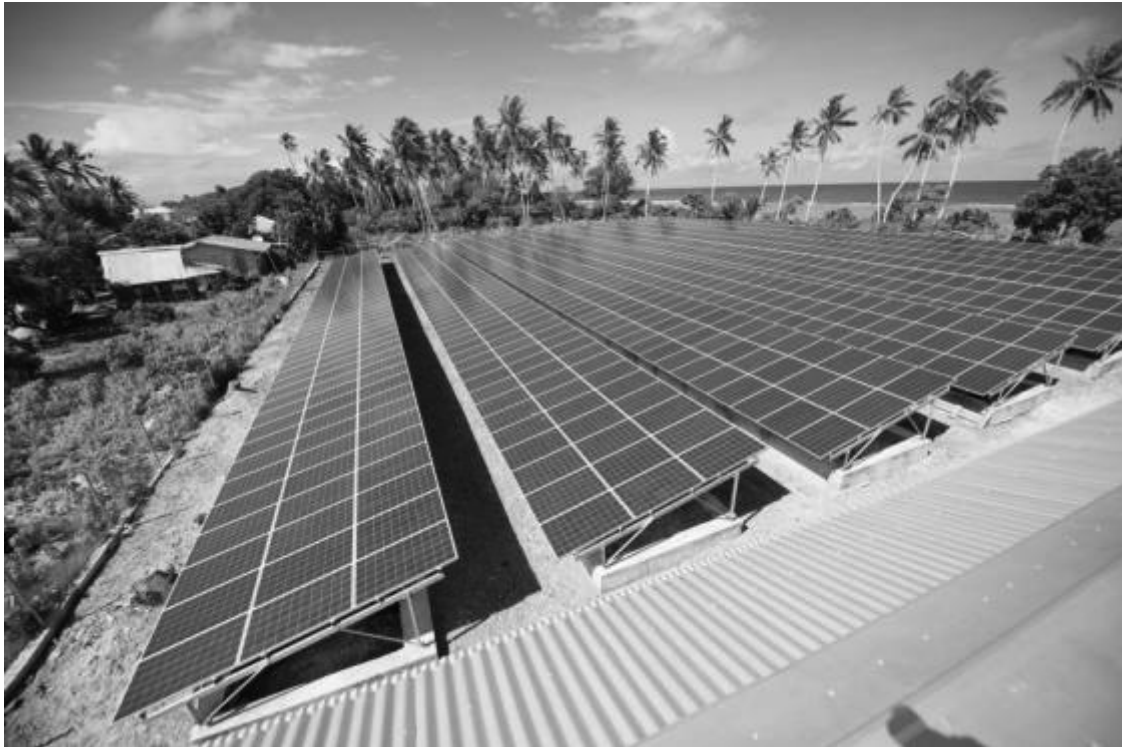
The area around the array was very clean and tidy. Vegetation had been cleared recently and there were no obstructions between the rows or shading on the panels.

**Figure 63: Area around the array is very clean and tidy**

None required, except regular clearing of any new vegetation.

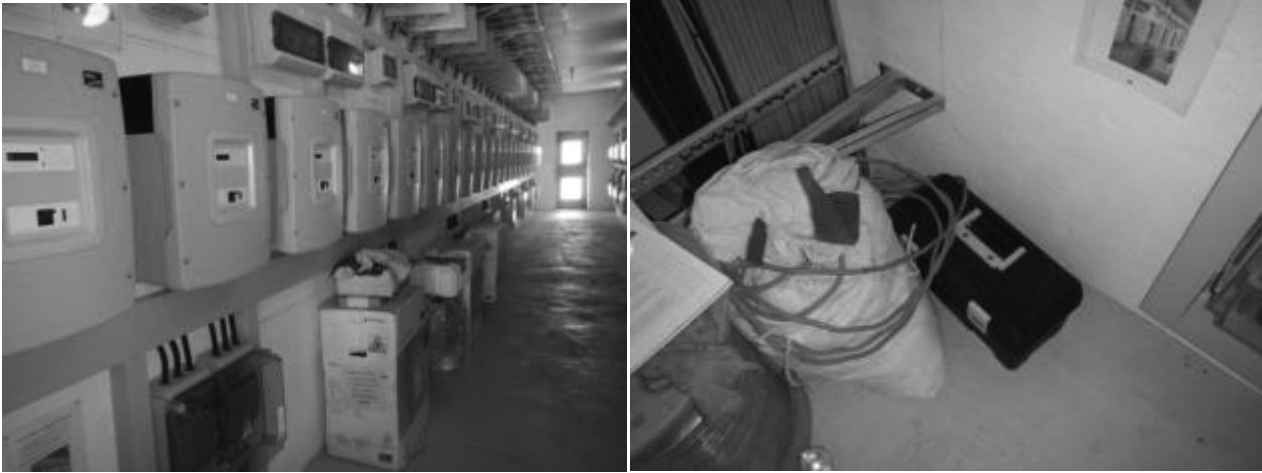
The inverter room was generally kept clean. There were three boxed spare Sunny Islands in the inverter room, kept to the side where they were not obstructing access to any equipment. Operators told us the spare Sunny Islands were there as they had recently finished trouble shooting the array shutdown after the lightning storm. A few other spare parts such as cabling were piled in the corner, and while these did not present a hazard or hide any other equipment, they should be tidied.

**Figure 64: Inverter room, spare Sunny Islands (left), toolbox and miscellaneous items (right)**

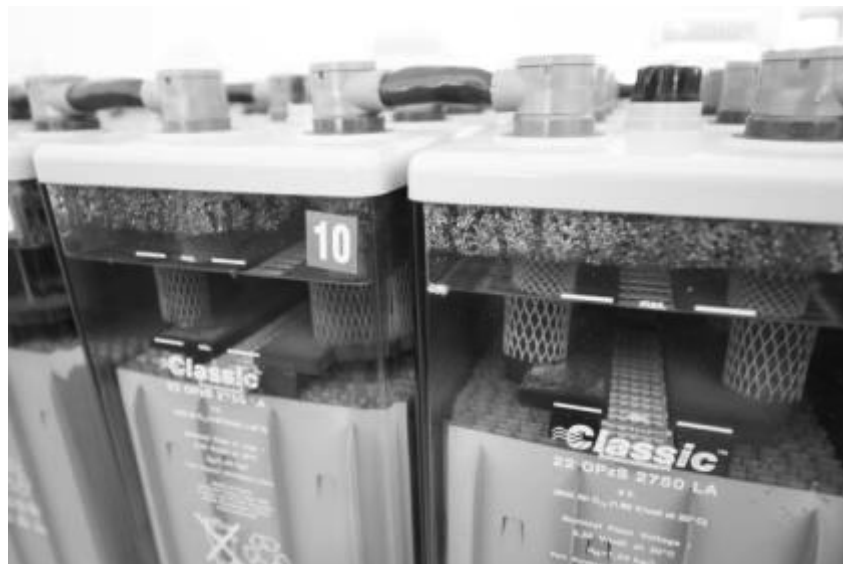
All battery electrolyte levels were close to the maximum line. Operators reported having topped up the battery electrolyte twice since the system was installed, and checking the electrolyte levels fortnightly.

**Figure 67: Battery electrolyte levels**

The schedule for checking and topping up batteries appears to be adhered to. Aside from regular checking and topping up of electrolyte no action is required.

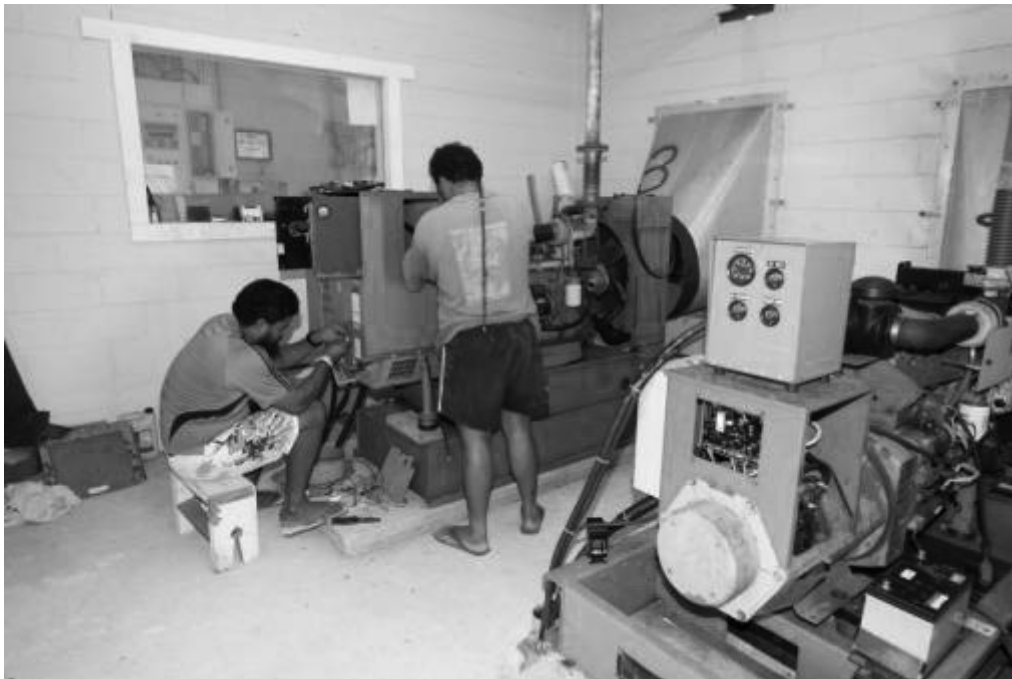
The operators reported that one of three generators was operational and that they were working on repairing a second generator. This repair work was taking place during our visit.

**Figure 68: Generator maintenance work underway**

Continue repair work on the second diesel generator so that there is redundancy in the event of the PV system going down.

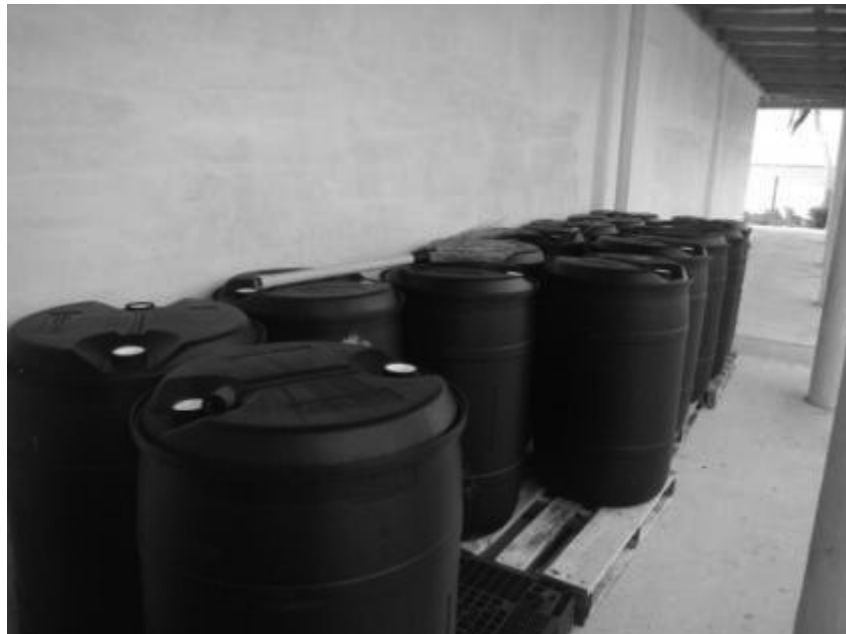
**Figure 69: Spare battery acid stored under cover**

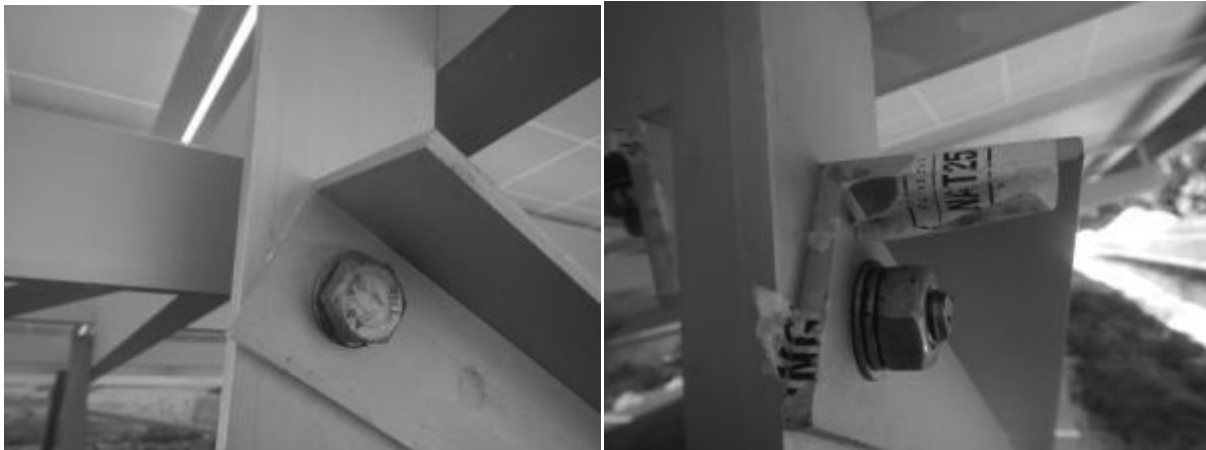
No signs of movement were observed, and none of the bolts randomly checked were loose. Figure 70 and Figure 71 show typical array frame details including bolts and general condition of the array frame. No structural problems were observed. Some small spot rust (“tea staining”) was observed on some of the bolts. Tea staining on stainless steel usually occurs around joins or edges (such as the lettering on the bolt shown) and is mainly a cosmetic issue unlikely to spread. Nonetheless, bolts should be checked regularly for any signs of more extensive rust

**Figure 70: Tea staining on bolts on the array frame**

Check bolts for signs of rust spreading. Monitor concrete footings in case cracking becomes more extensive.

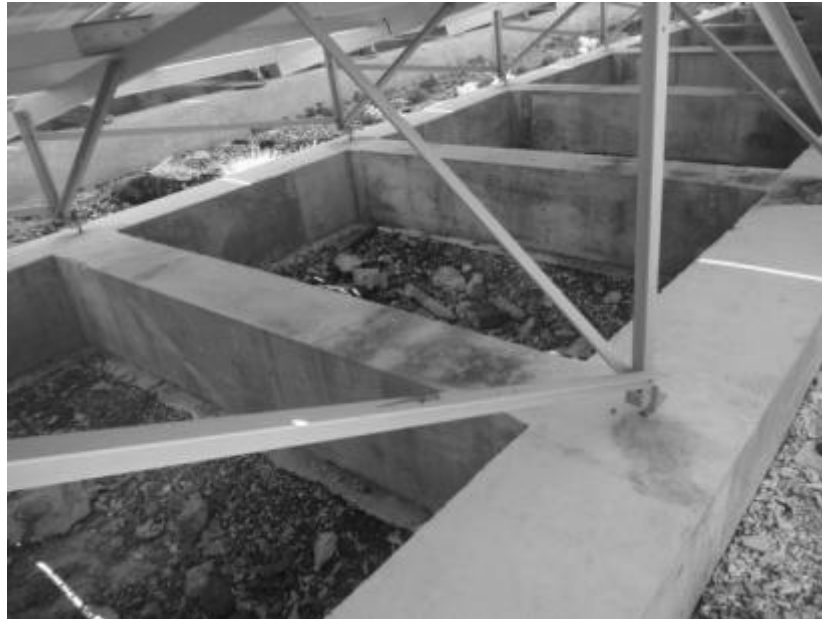
**Figure 71: Array frame detail**

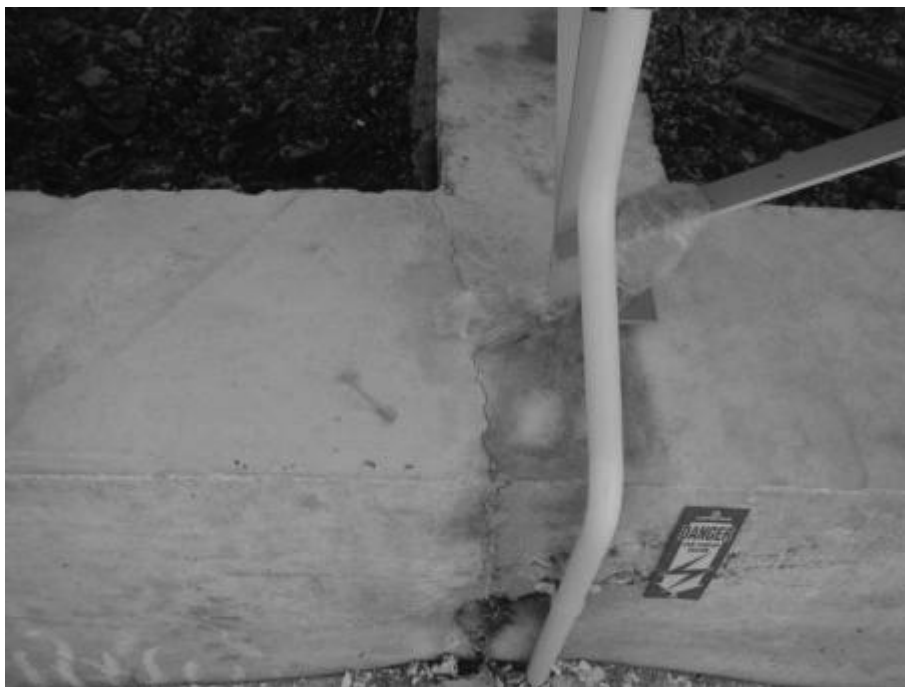
Visual inspection of concrete footings revealed some small cracks in the concrete around the array mounting points. These cracks do not currently pose a structural risk but they should be monitored in case cracking becomes more extensive.

**Figure 72: Small cracks in concrete foundations**

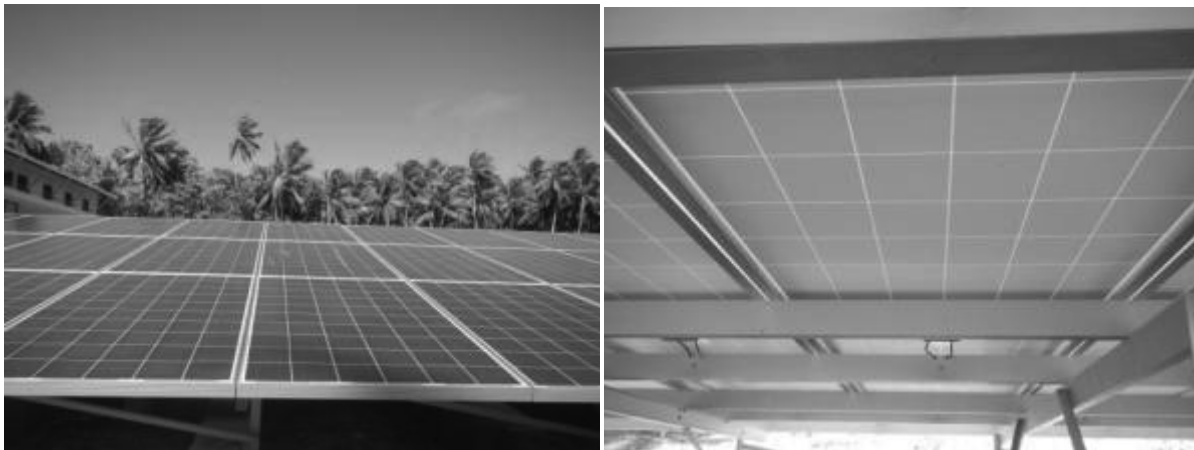
No signs of damage or hot spots were observed. Figure 73 shows typical panel front and back surface appearance. No dark spots, peeling or cracking were observed on any part of the array.

**Figure 73: Typical panel detail**

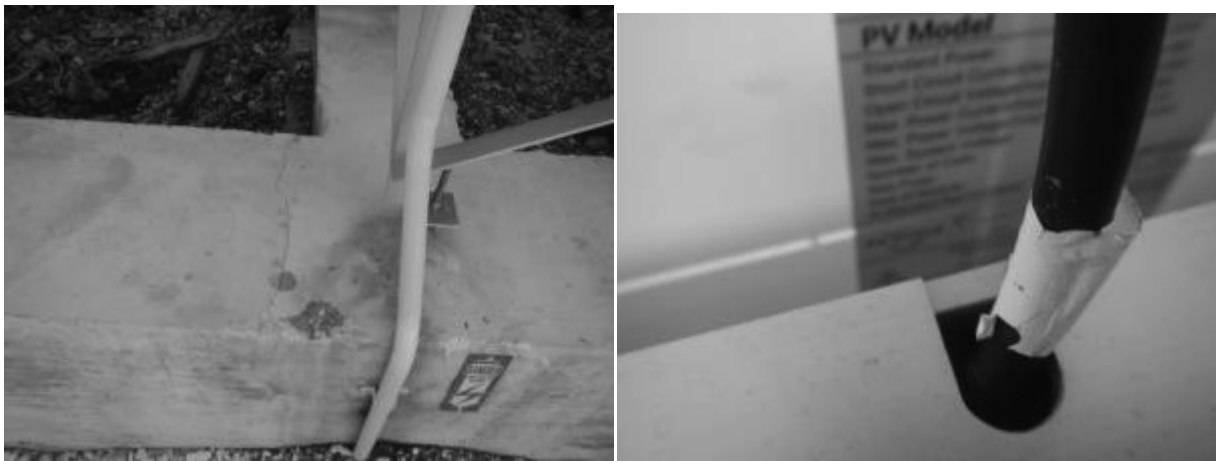
Exposed conduit (Figure 74) was in good condition and suitably tied up to prevent accidental damage from movement.

Cable entries to ducting have sharp edge and in some cases the cables were pulled up against these edges (Figure 74). Some scratching on the outer insulation of the cables was observed, but no deep cuts in the insulation were found. Wiggling the cables produced very little movement so it is unlikely that they are rubbing against the edges due to movement. Nonetheless these points on the array should be monitored to ensure that the cable insulation is not damaged over time.

**Figure 74: Conduit detail (left) and minor scratches on cables (right)**

No immediate rectification work is required. However, cables entries to the ducting (as shown in Figure 74) should be checked regularly for signs of damage.

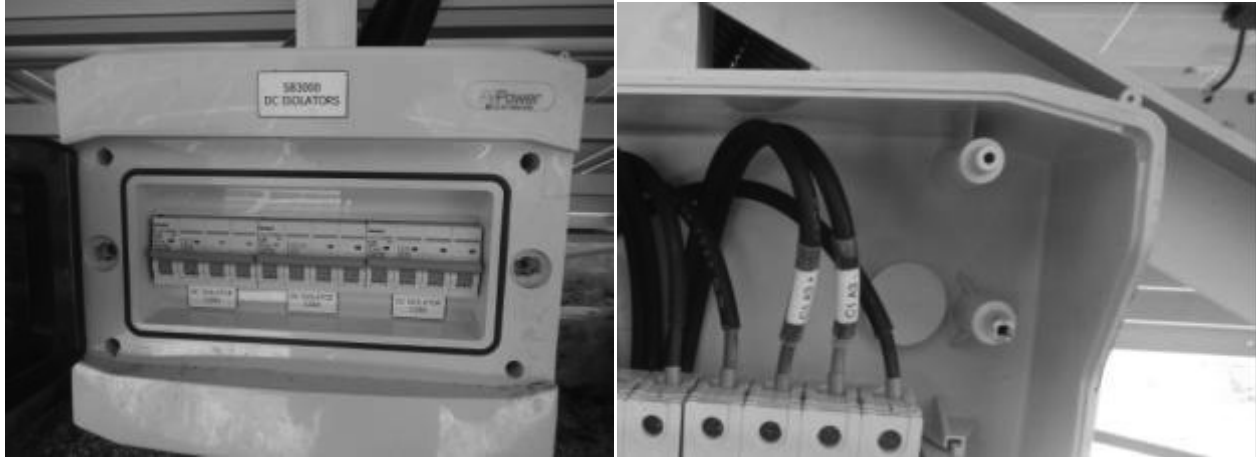
All labels were checked and none were found to be missing, damaged or incorrect.

Screw mounts inside the isolators are showing some signs of wear (Figure 75) indicating that they may need replacing after several years of opening and closing the isolators.

**Figure 75: Isolator enclosure labelling (left) and screw mounts (right)**

Screw mounts are showing some signs of wear and may deteriorate after several years of opening the isolator enclosures. Staff should ensure that spares are available should they be required.

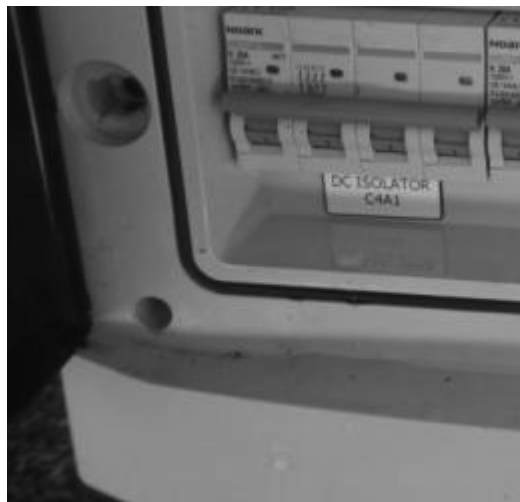
Two wasp nests were found in enclosure screw holes. These were easily removed with a screwdriver. Infestation does not appear to be a major problem at this site.

**Figure 76: Small wasp nest easily removed with screwdriver**

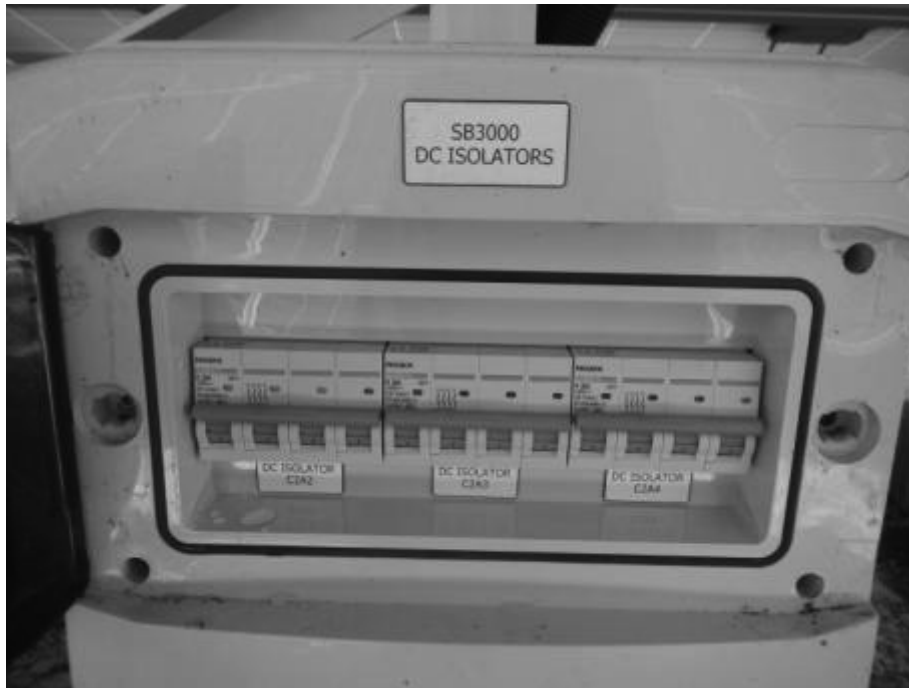
The inspection took place just after a major storm and the isolator enclosures were wet and dirty on the outside and under the clear covers. However, when we opened the enclosures they were enclosures were clean and dry inside. There was no evidence of any previous water ingress.

**Figure 77: Water and mud on outside of isolator enclosures after a major storm**

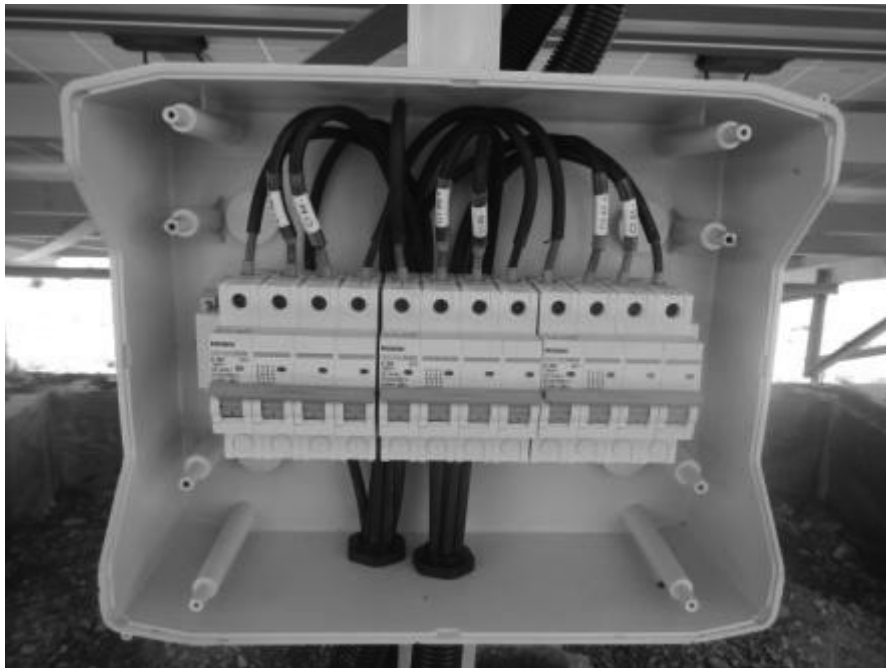
**Figure 78: Enclosures were clean and dry inside**

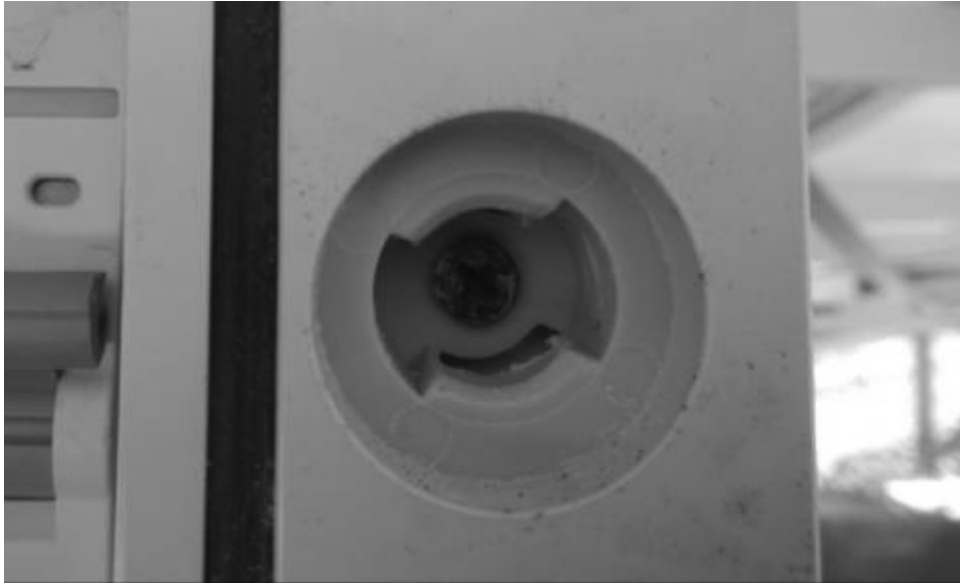
There were no signs of corrosion on the isolators. Mounting screws used in the enclosures were all stainless steel and showed no signs of corrosion. However, small screws used for the latching mechanism were galvanized steel and were corroding. These should be replaced with stainless steel screws.

**Figure 79: Corroded galvanized steel screw on enclosure latching mechanism**

Galvanized steel screws used on the enclosure latching mechanism need to be replaced with stainless steel screws.

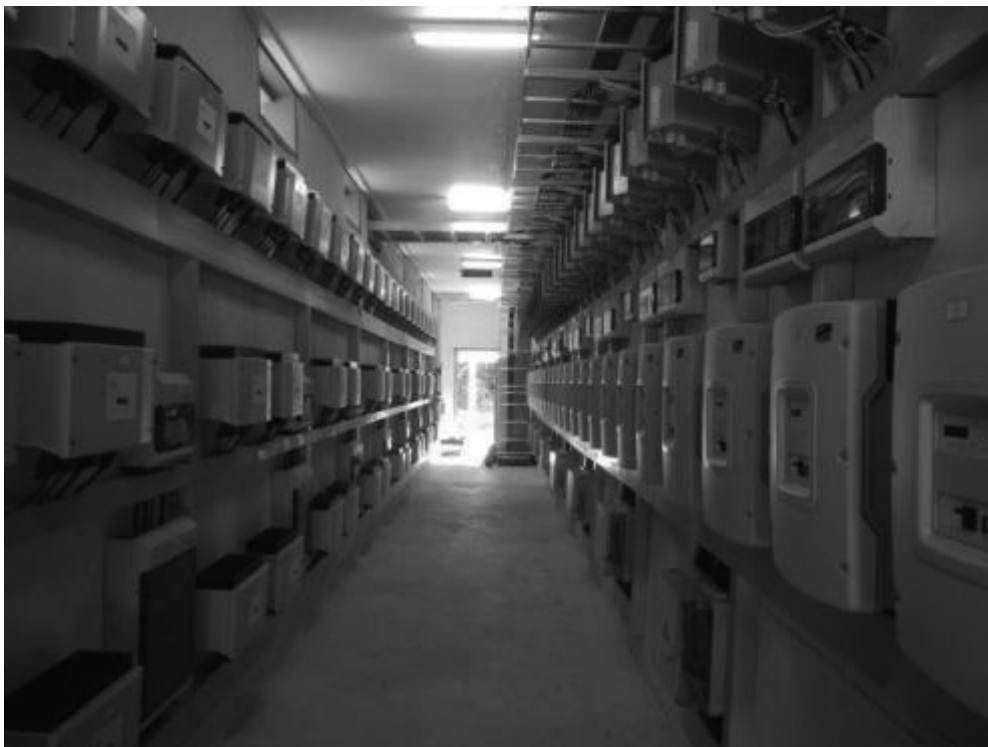
Temperature measurements were 41°C throughout the room. A measurement taken above an inverter heat sink read 45°C. Ambient temperature (outside in semi-shade) was 34°C. This room temperature is too high and forced ventilation is recommended for the room.

**Figure 80: Inverter room with natural ventilation (top left)**

Large extractor fans are recommended for this room.

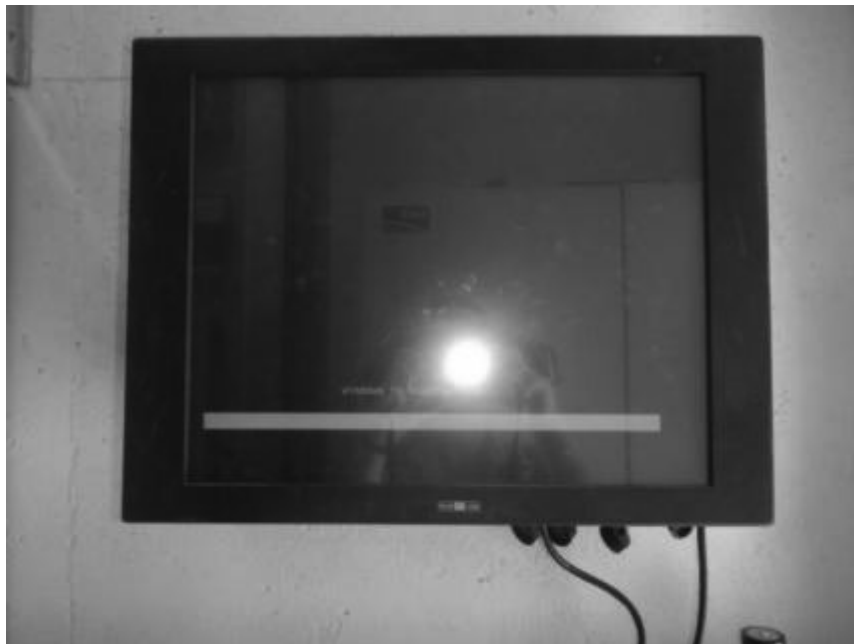
The inverter room display computer was not working. Attempts to reboot the computer revealed that the hard drive was damaged. This computer needs to be sent for repair or replacement. This is the second hard drive failure of the inverter room computer at this site and there was also a previous hard drive failure at Fakaofu. Both these sites had excessive temperatures in the inverter room so this is a likely cause of the failures.

**Figure 81: Inverter room computer failed to boot due to hard drive failure**

The inverter room computer needs to be sent back for repair or replacement. Heat is a likely cause of this failure, so it is important to reduce the inverter room temperature.

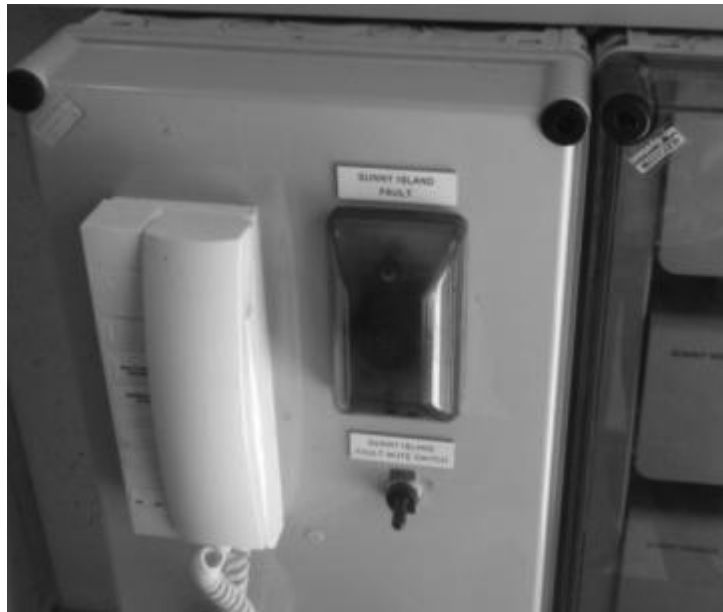
Operators reported no erroneous tripping. The Sunny Island Fault Mute Switch was in the “OFF” position.

**Figure 82: Fault mute switch in OFF position**

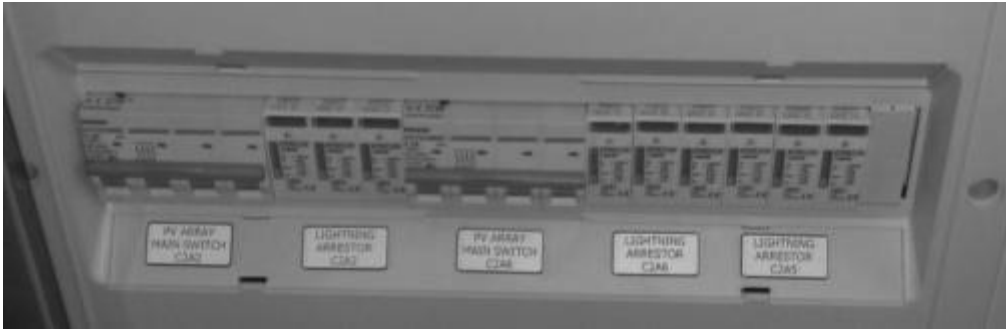
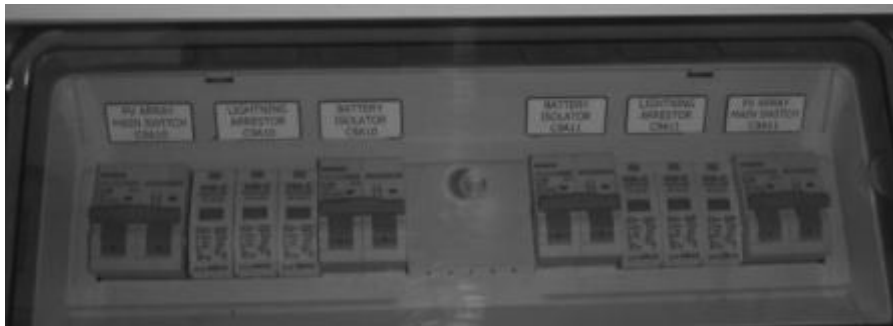
All Sunny Boy lightning arrestors were intact (for these arrestors a red button pops out when the arrestor is tripped).

**Figure 84: Surge arrestors intact**

**Figure 85: Surge arrestors intact**

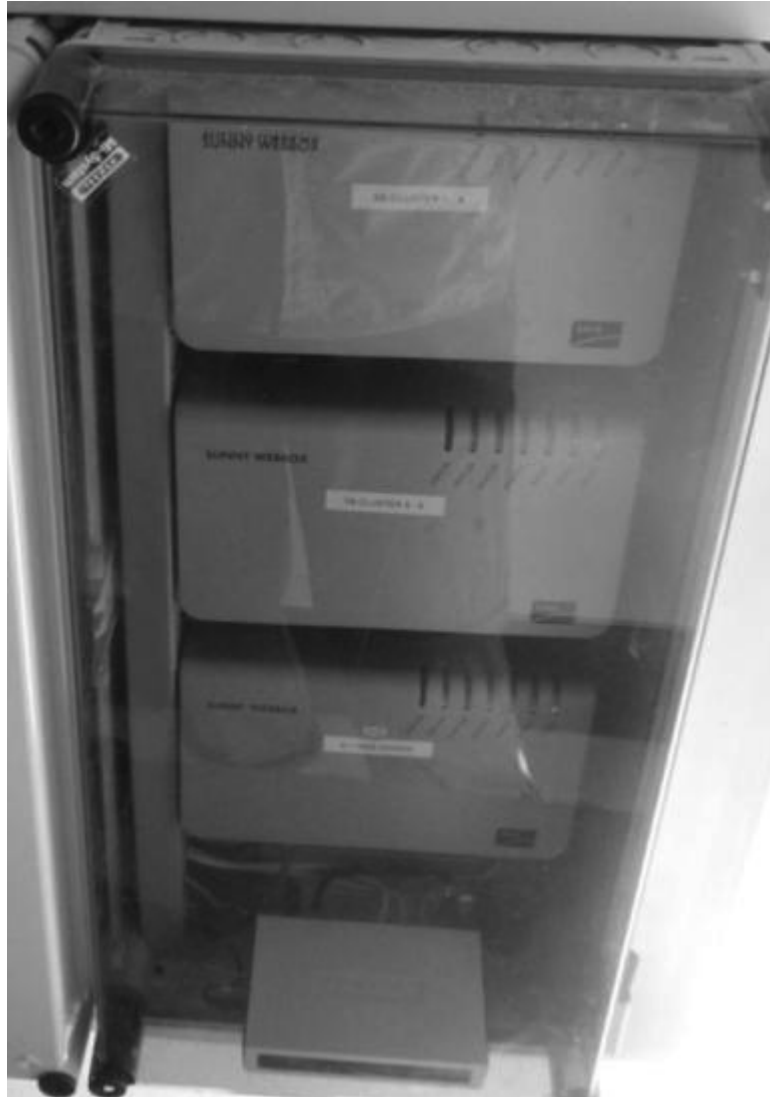
At the time of the inspection, all internet wiring was intact and undamaged and the Webboxes were online. The Webboxes all contained SD cards that were successfully logging data.

**Figure 88: Webboxes online and logging**

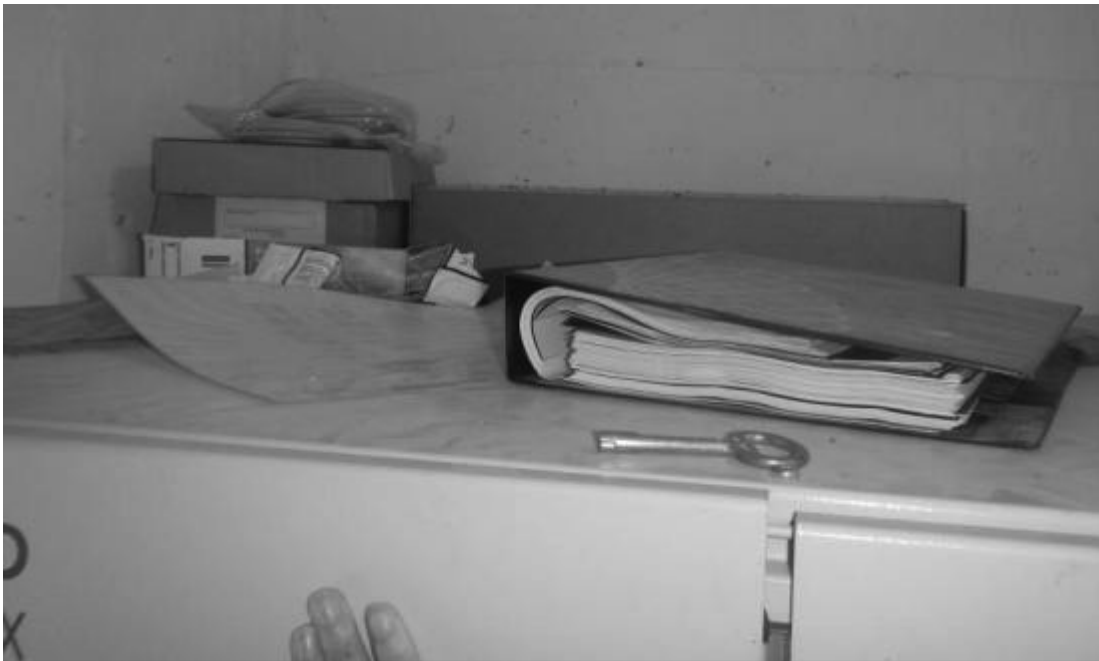
The system manual and array wiring diagram were found on top of the main electrical cabinet.

**Figure 89: Manual and array wiring diagram on top of cabinet**

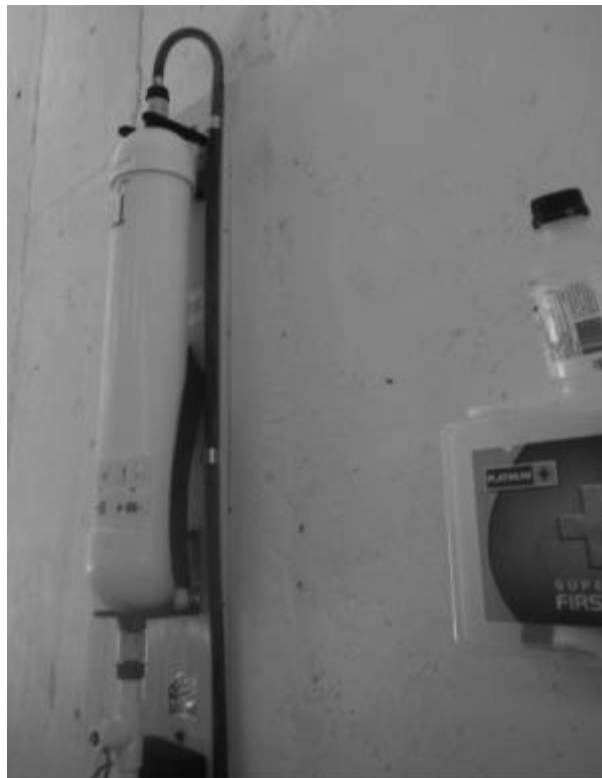
A deionizer was mounted on the wall in the battery room. The indicator light was off and operators told us they had removed the battery as the light kept flashing. The battery was located nearby and the light was green when it was inserted. Operators said they had a spare filter should one be required.

**Figure 90: Deionizer**
