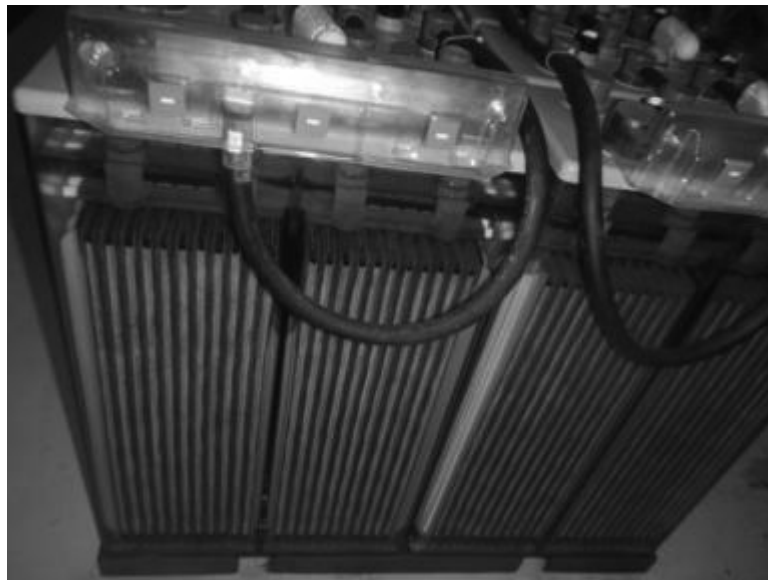
No signs of sulfation were observed. Battery water levels were all close to the maximum level. Small lead deposits (up to 5mm deep) could be seen in the bottom of the batteries. These were not considered excessive. No signs of physical damage were observed and all terminals were insulated.

**Figure 91: Battery plates free of sulfation**

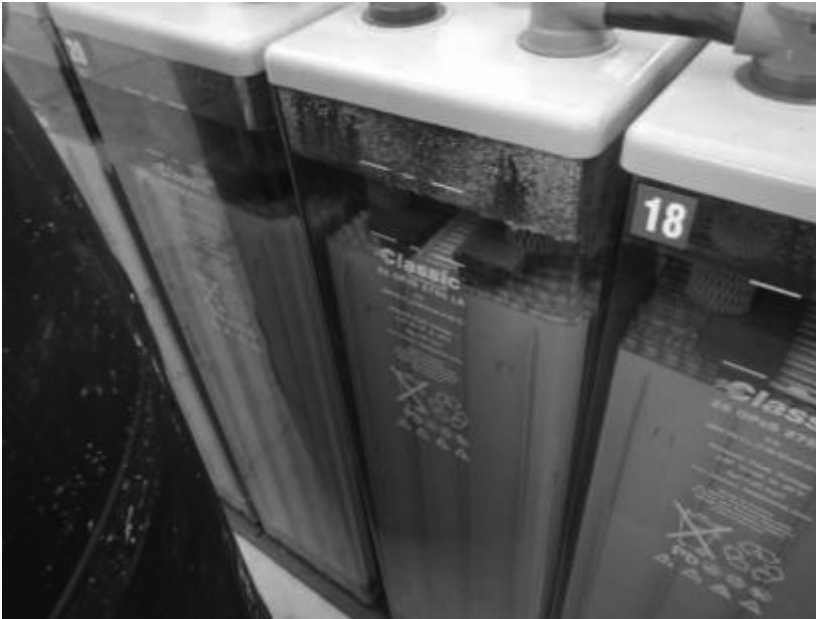
One new battery had been swapped into Cluster 2 String A after a dead cell was found during the Exide visit in April. This battery had some orange debris floating in the top and noticeably more condensation than the other batteries. The water level was also slightly lower. The extra condensation is caused by gassing within the battery as it attempts to equalize with the rest of the bank. The water level should be monitored as this battery may need topping up earlier than others. Exide have advised that the orange debris is a small amount of Darak (a type of polymer material used between the plates) which is inert and not a cause for concern.

**Figure 92: New battery with some orange debris floating in the water**

Battery 19, Cluster 2 string A should be monitored for water level, damage and battery health as it is still equalizing with the rest of the string.

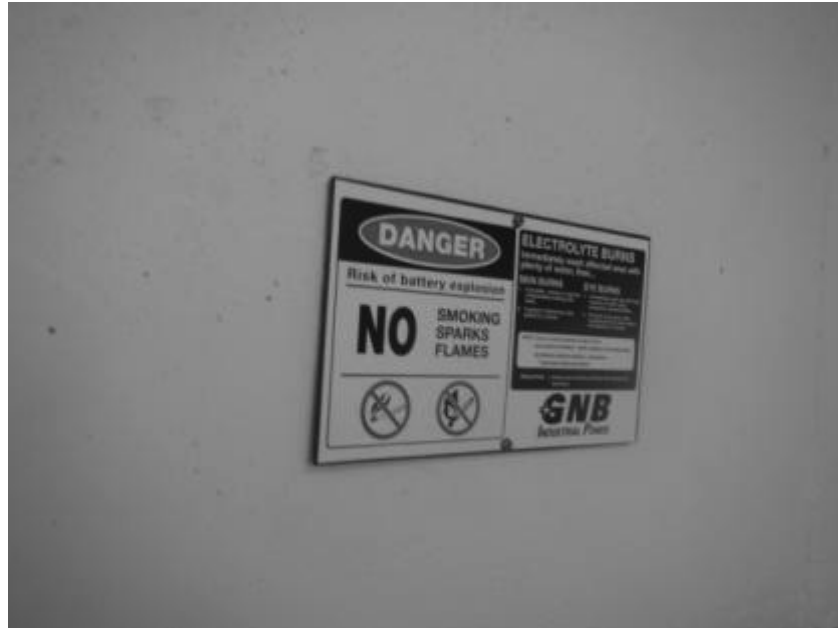
Appropriate warning labels were mounted on the walls at both ends of the battery room. The new battery (Battery 19, Cluster 2 string A) was missing a number and this should be added. There were no string numbers painted on the wall as there were at Fakaofu.

Figure 93: Warning labels in battery room

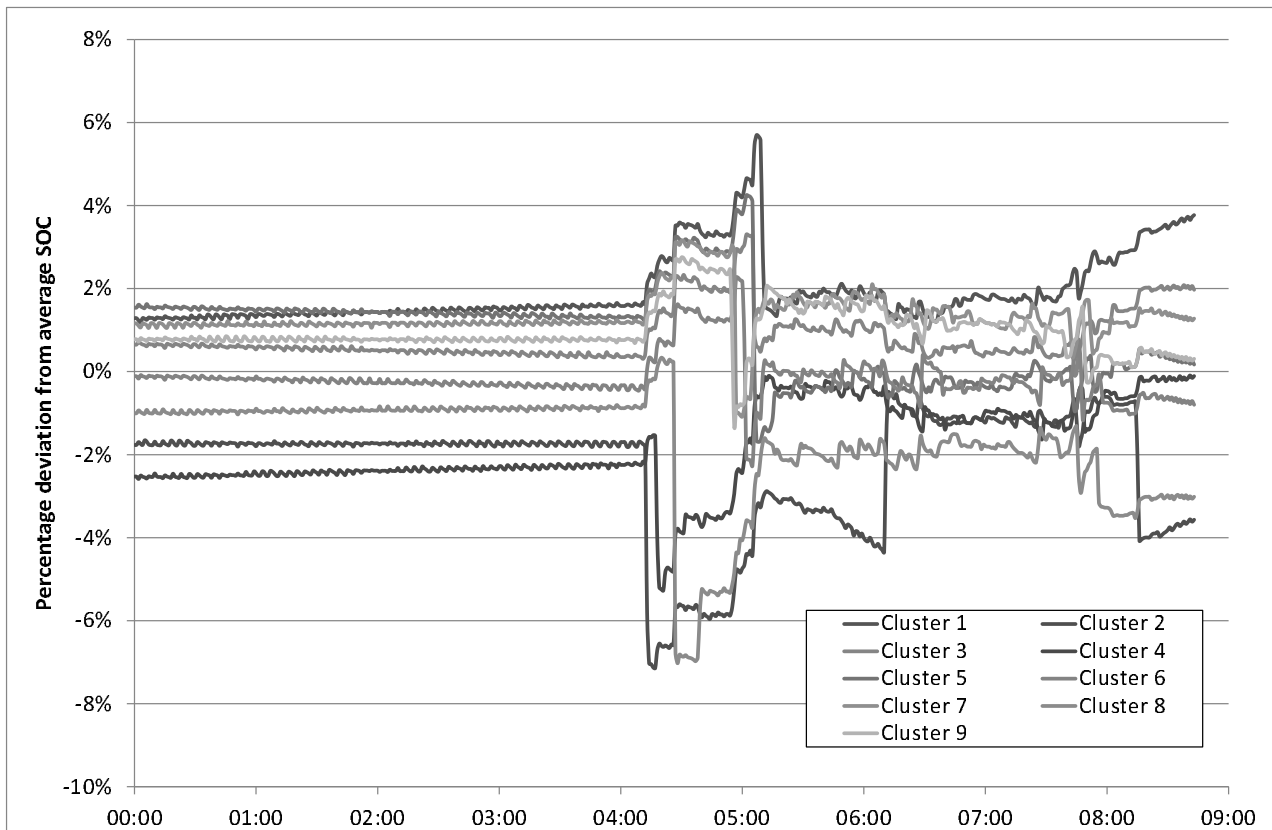
sudden actual drops in SOC. Cluster 3 is 1-4% higher throughout the day than the average, while Cluster 5 is 1-3% lower than the average. These deviations are small enough not to be considered problematic. The step changes in SOC may indicate that the Sunny Island algorithm for calculating SOC is problematic.

**Figure 94: Deviations in battery cluster SOC from average over a day (07 June 2013)**

There do not appear to be major deviations in the battery SOC across battery banks. General battery monitoring and testing should continue according to the schedule, and Battery 19, Cluster 2 string A should be monitored for water level, damage and battery health as it is still equalizing with the rest of the string.

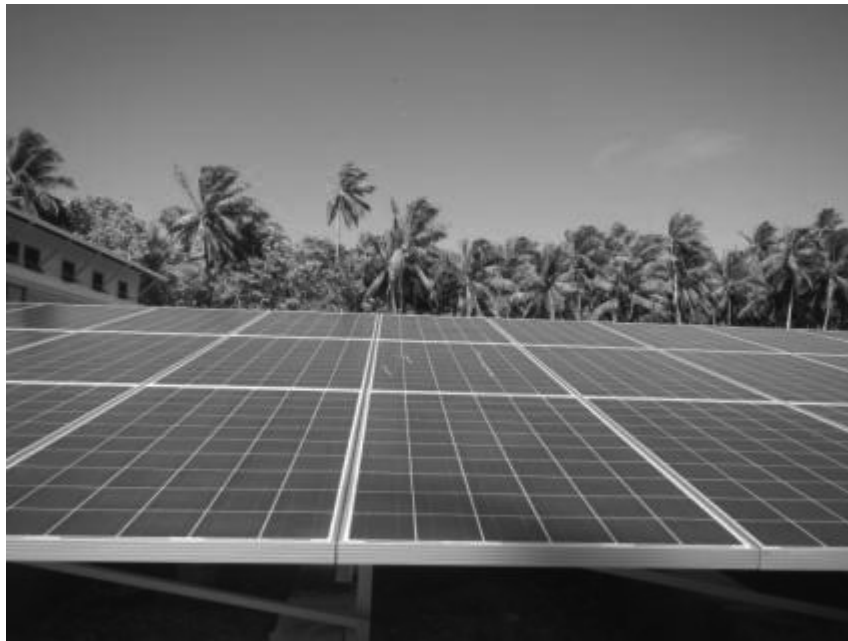
Overall the panels were clean and free from any signs of excessive build up of dirt or droppings. There were some bird droppings on the panels but these were not excessively stubborn and appear to wash off in rain storms.

**Figure 95: Panels generally clean**

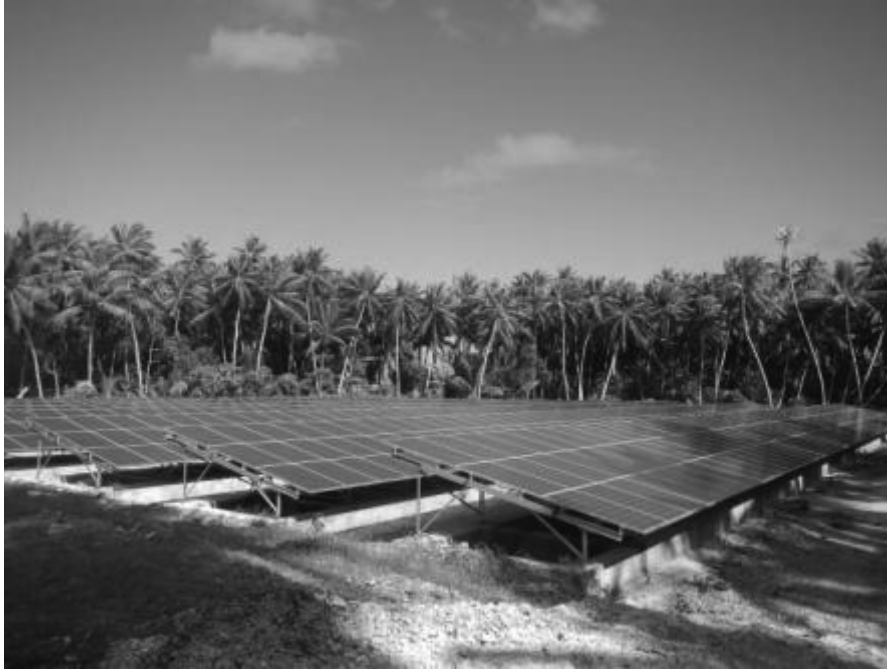
**Figure 96: Minimal vegetation around panels; shading on front row from trees on adjacent land**

landholder will be needed to remove the new trees. This should be investigated before the trees get too large.

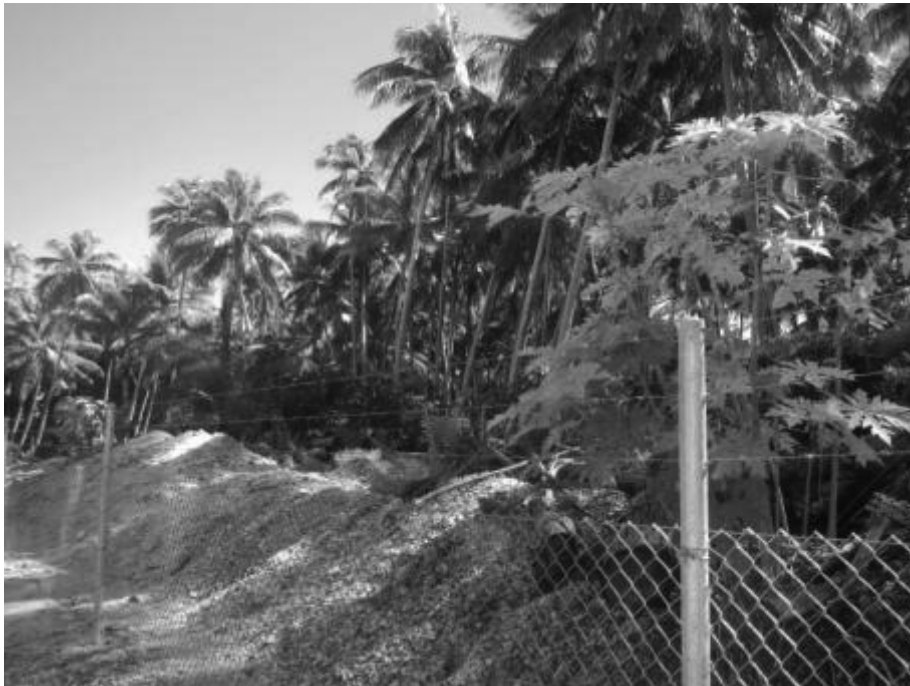
**Figure 97: New trees growing on cleared land adjacent to array**

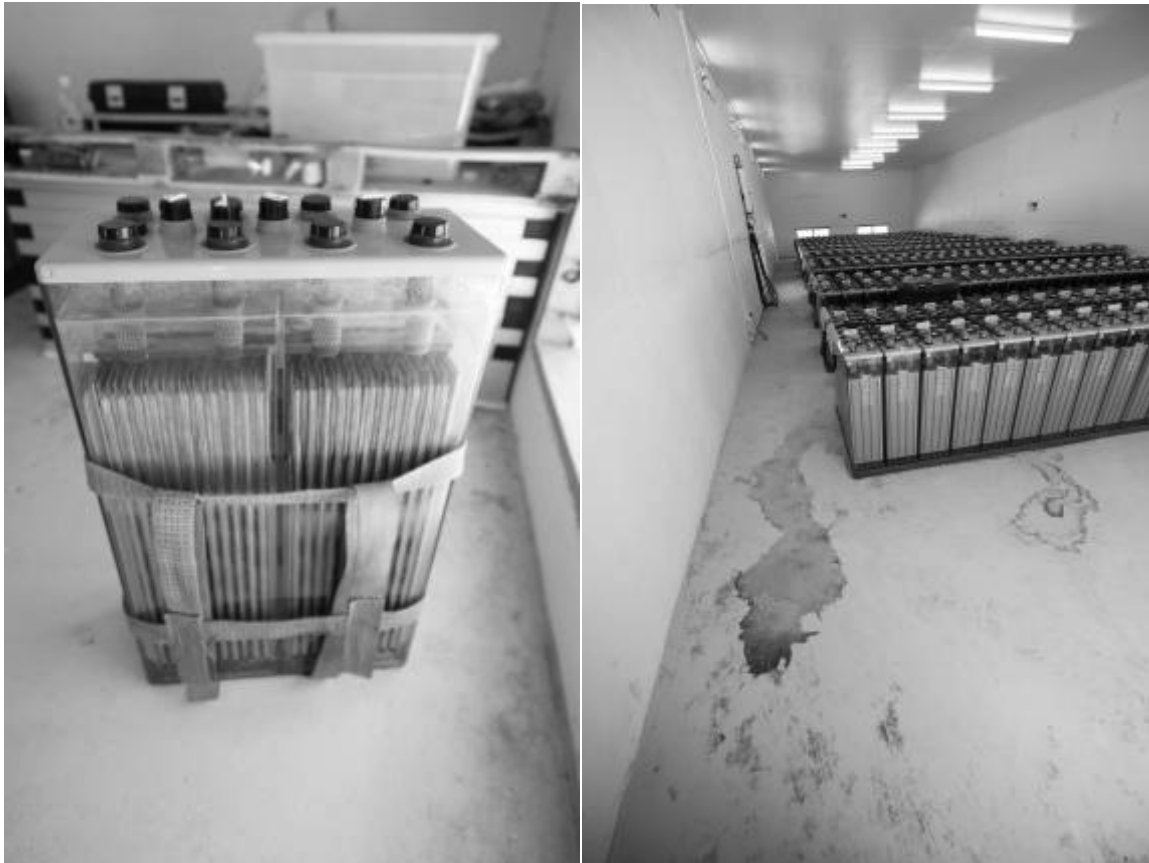
The battery room required some cleaning. Water had spilled on the floor (apparently from the deionizer) and had not been cleaned up. A drum of battery acid was stored between the rows of batteries, restricting walking access to that row. The dead cell previously removed was sitting next to the door. The toolbox and some miscellaneous equipment was stored on top of a pallet of spare panels in the corner of the room.

**Figure 99: Dead cell, and storage area in battery room (left), water on floor (right)**
