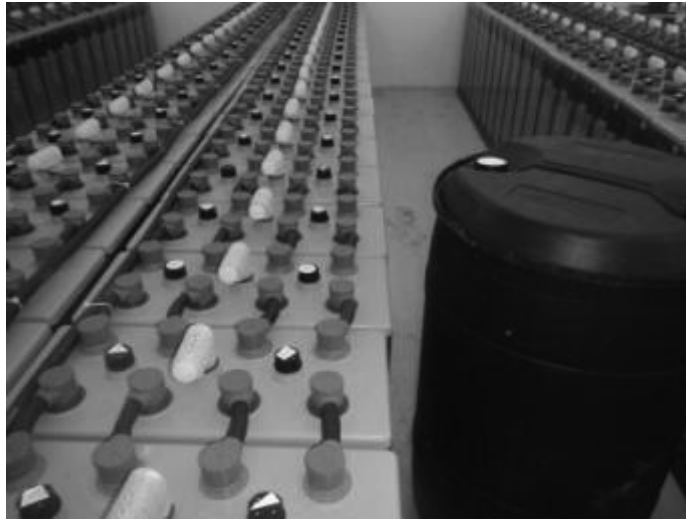
**Figure 100: Drum of battery acid obstructing row**

Water on the floor needs cleaning up and the deionizer should be checked for leaks. The drum of battery acid needs to be moved out of the way to a safe storage area. The dead cell should be prepared for shipping back to Exide, as a warranty claim can be made for the dead cell.

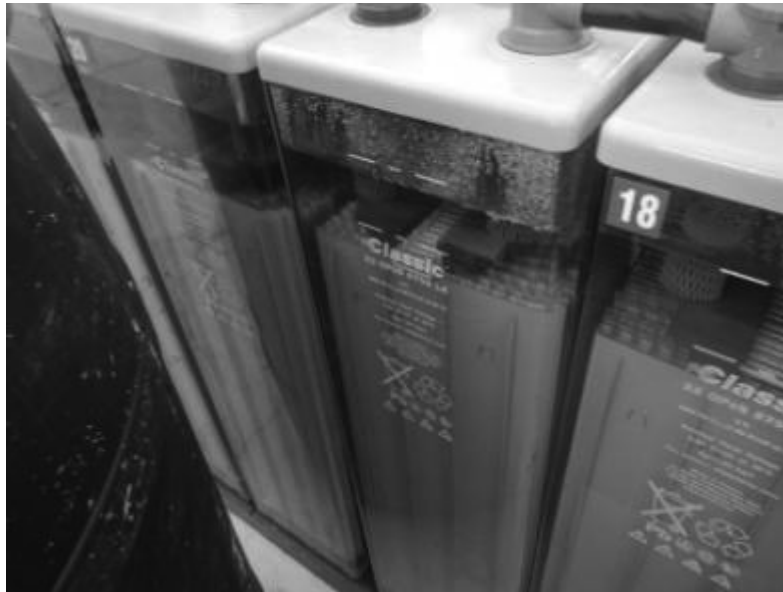
All battery electrolyte levels were close to the maximum line except the new cell, which was slightly lower. Operators reported having topped up the battery electrolyte twice since the system was installed, and checking the electrolyte levels fortnightly. The new cell may need to be topped up earlier than the others.

**Figure 101: Battery electrolyte levels on old and new cell**

The new cell (19, String A Cluster 2) should be checked and monitored. The schedule for checking and topping up batteries appears to be adhered to. Aside from regular checking and topping up of electrolyte no action is required.

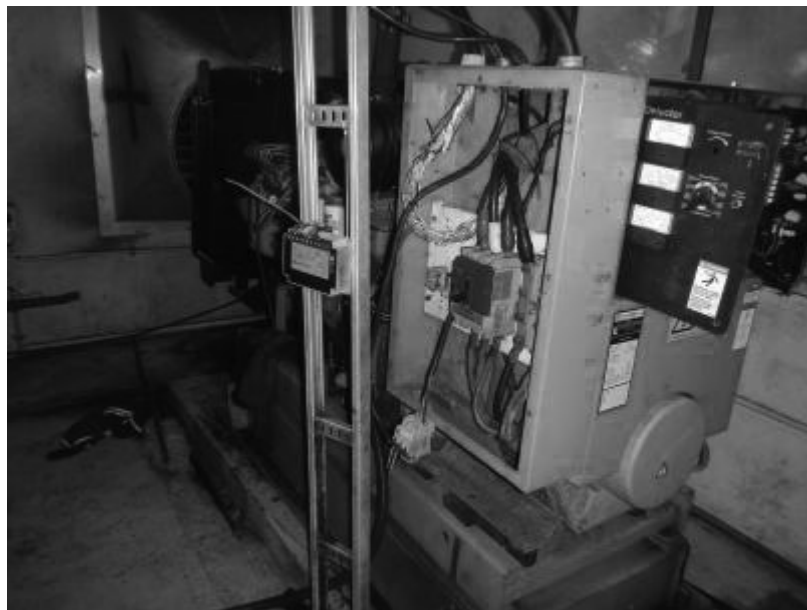
The operators reported that one of three generators was operational, though with some errors. The generator room was very untidy with clothes, rubbish and miscellaneous equipment on the floor and on the generators (Figure 102).

**Figure 102: One working generator**

The generator room needs to be cleaned up and the generator needs maintenance work. A second generator also needs to be returned to operational status to provide redundancy in the event of a PV system shutdown.

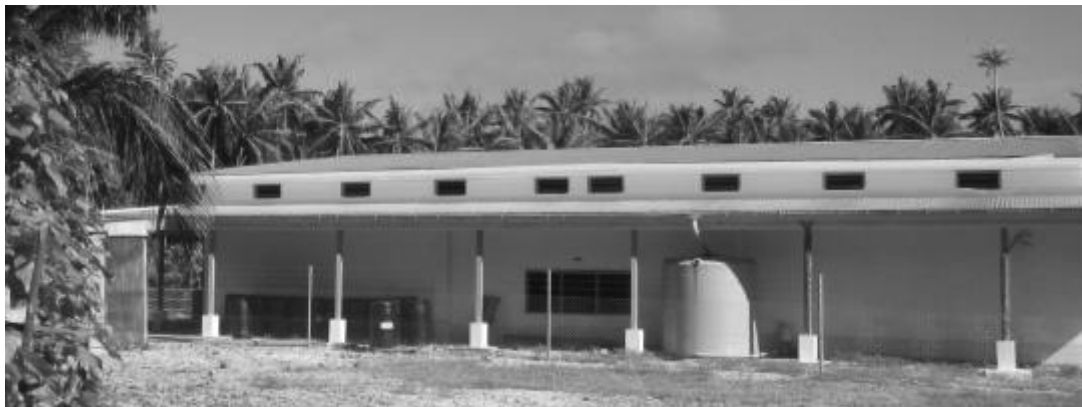
There are now no spare batteries on site. Of the 6 spare batteries included in the design, 5 were lost during unloading, leaving only one spare on site. That spare has been used and not replaced. The faulty cell identified by Exide should be replaced under warranty, so it is very important that the staff request a new battery so that there is at least one spare on site. The faulty cell should be returned to Exide.

**Figure 103: Battery acid drums**

Make a warranty claim to Exide for the faulty battery and have a new battery delivered to site to act as a spare. Return the faulty battery to Exide.
