PART 2- TECHNICAL REVIEW

1. Fakaofu System Review

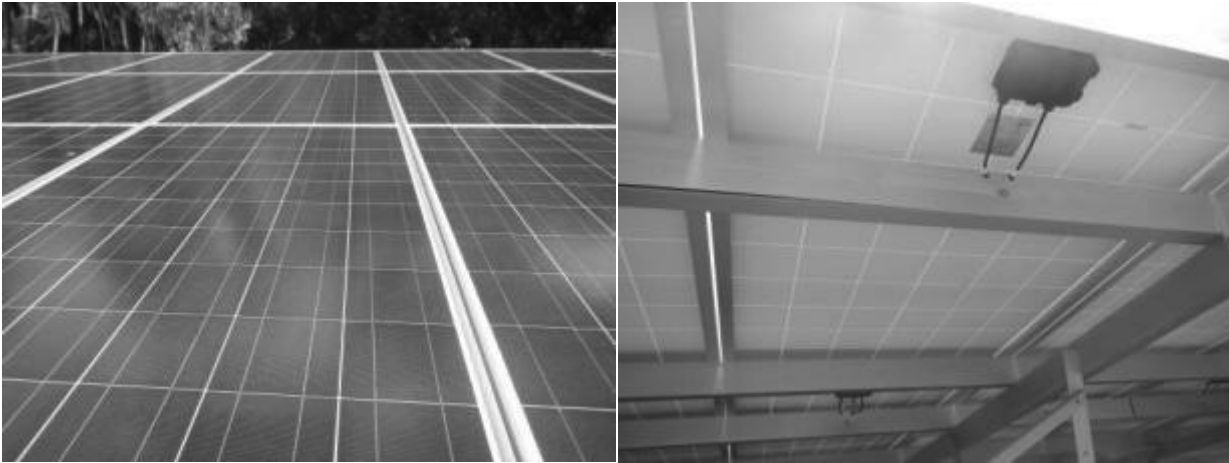
No signs of damage or hot spots were observed. Figure 6 shows typical panel front and back surface appearance. No dark spots, peeling or cracking were observed on any part of the array.

Figure 6: Typical condition of panels

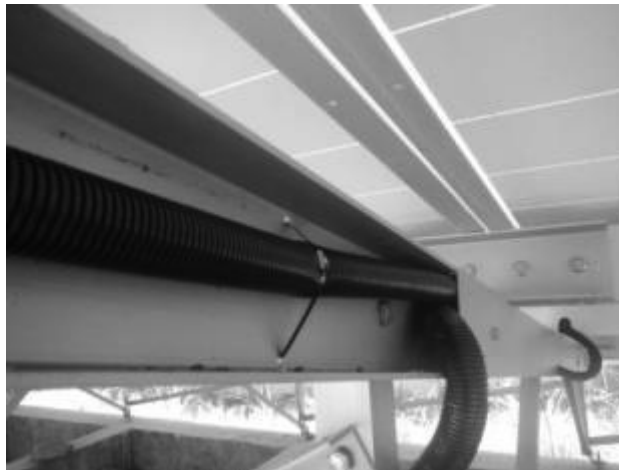
Exposed conduit (Figure 8) was in good condition and suitably tied up to prevent accidental damage from movement.

Figure 8: Conduit detail

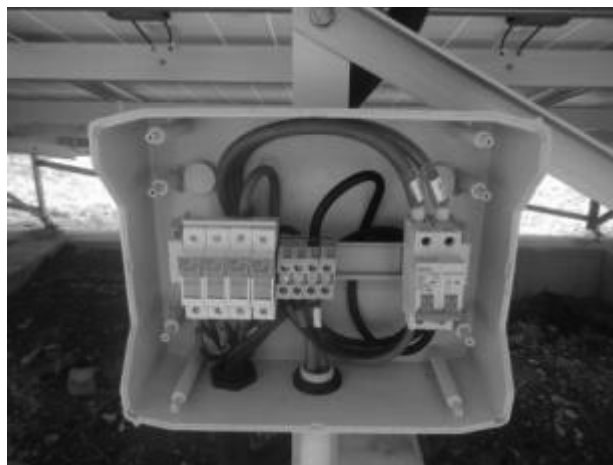
Isolator enclosures were clean and dry inside. There was no evidence of any previous water ingress. The enclosures are mounted under the array, giving them good protection from rain under most circumstances.

Figure 11: Typical isolator/fuse enclosure showing no sign of water ingress or loose cables

Cable terminations on the isolators were checked for any movement by wiggling them. No loose connections were found and there was no evidence of any cables having moved since installation. Cable terminations were appropriately done with no sign of exposed copper wire inside the enclosures (Figure 11).

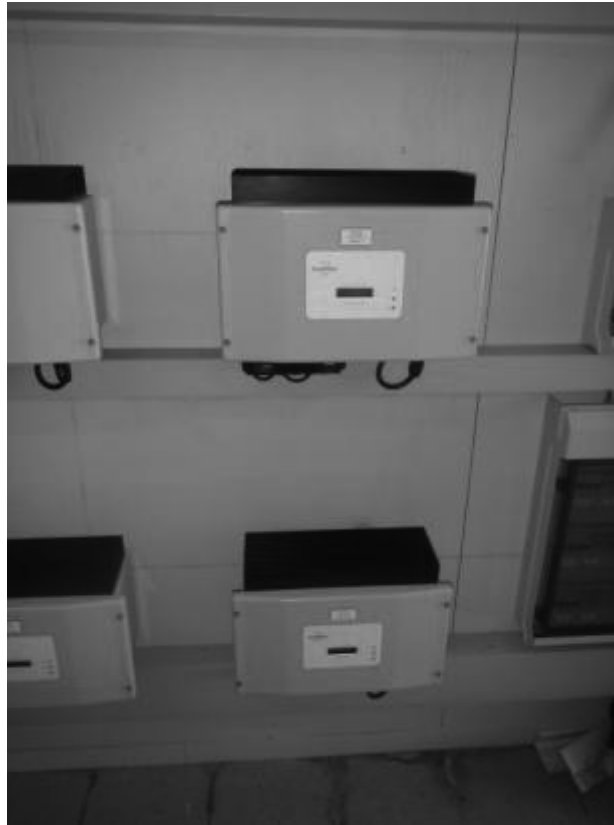
All labelling was attached to equipment and was correct.

Figure 16: Labelling on inverters

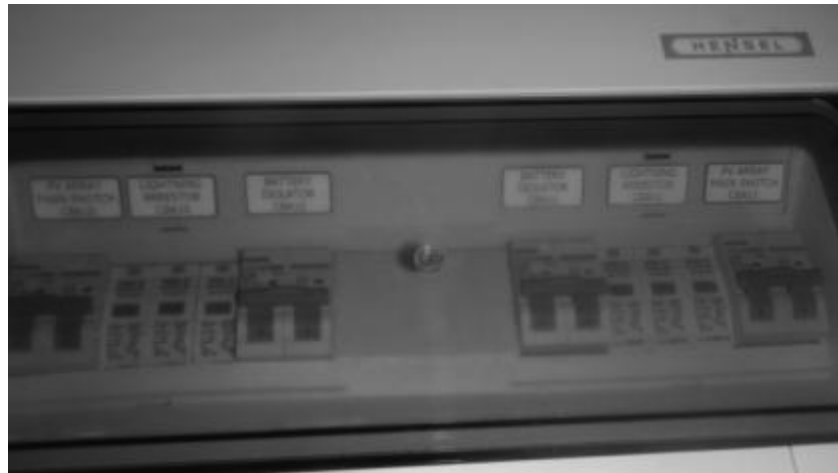
Figure 17: Lightning arrestors flagged green

All Sunny Island lightning arrestors were flagged green indicating they were operating normally and had not tripped.

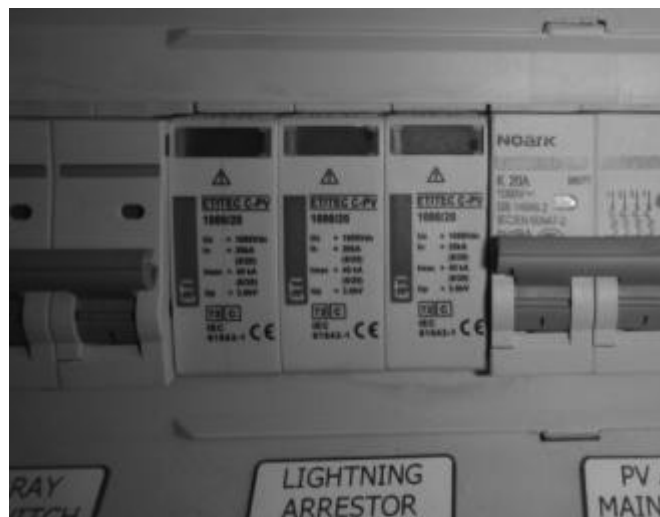
Figure 18: Sunny Boy lightning arrestors intact (red button pops out when tripped)

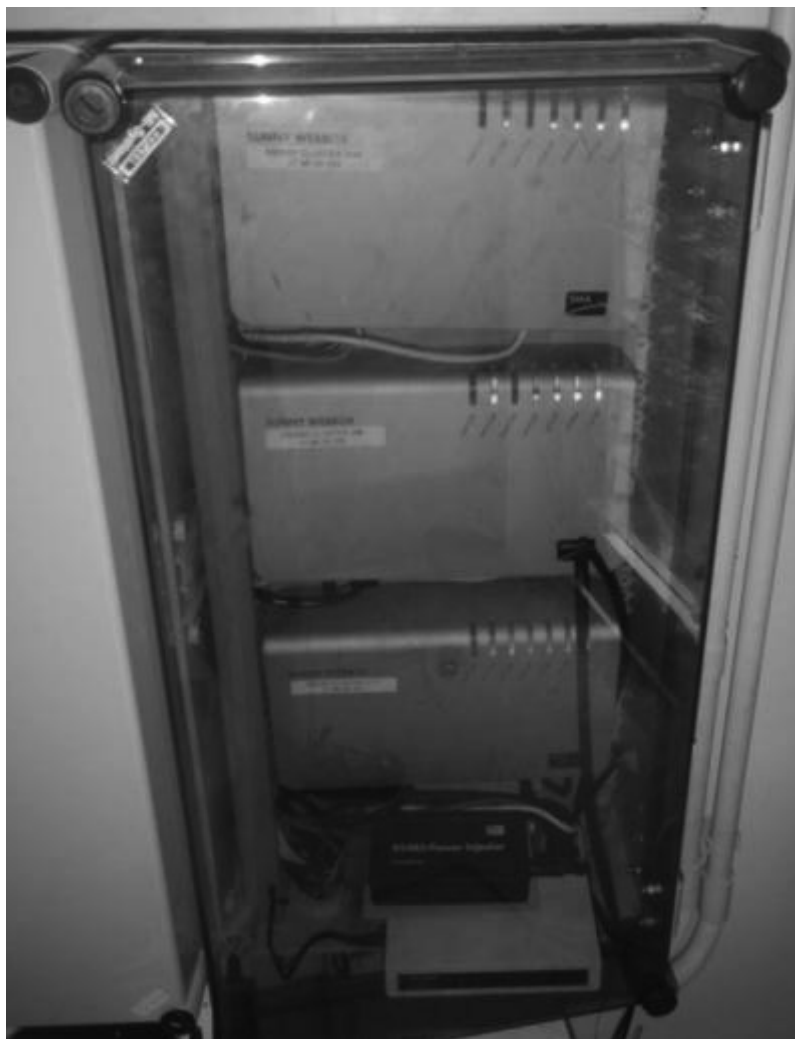
At the time of the inspection, all internet wiring was intact and undamaged and the system was online. The Sunny Webboxes indicated that they were online and transmitting data (Figure 20).

Figure 20: Webboxes connected and online

Two of three Webboxes (top two shown in Figure 20) were missing SD cards and they could not be found anywhere nearby. The SD cards store data regularly and can be used as a backup to access data when the internet connection fails. As the SD cards are missing, there may be data lost for some days when the internet connectivity was down. We had spare SD cards on hand and left new 2GB SD cards in the two Webboxes that were missing cards.

No remedial work is required. As the SD cards appear to have gone missing, the Director of Energy should investigate the issue of local operators taking SD cards off site.

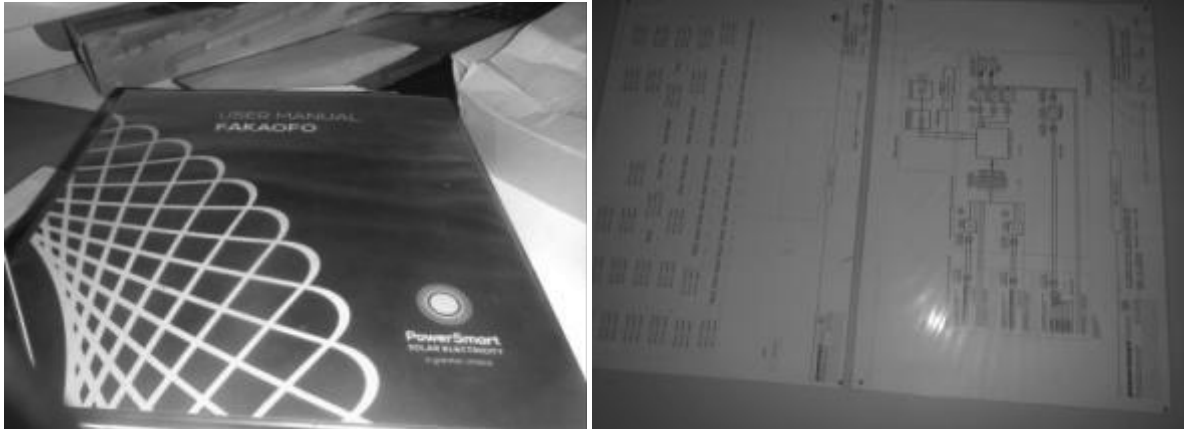
Shutdown procedure and maintenance schedule were also laminated and mounted on the wall near the operator desk.

Figure 22: User manual located on operator desk in inverter room and laminated diagrams on wall

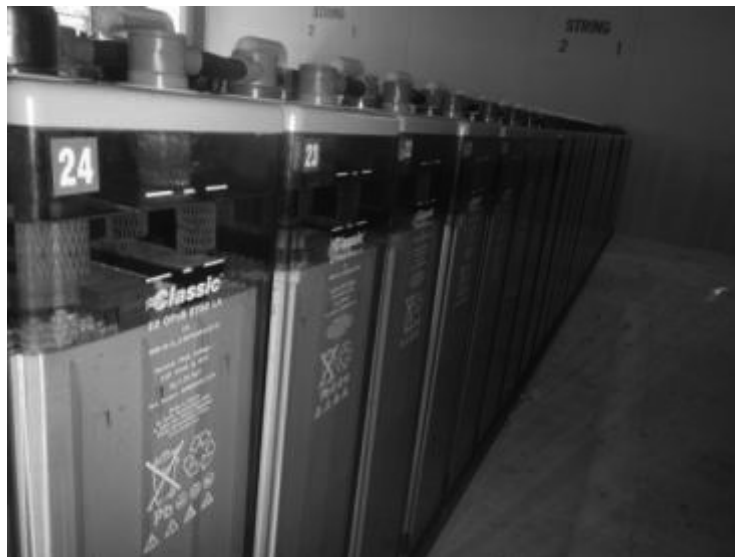
Figure 25: Water level on batteries near maximum line

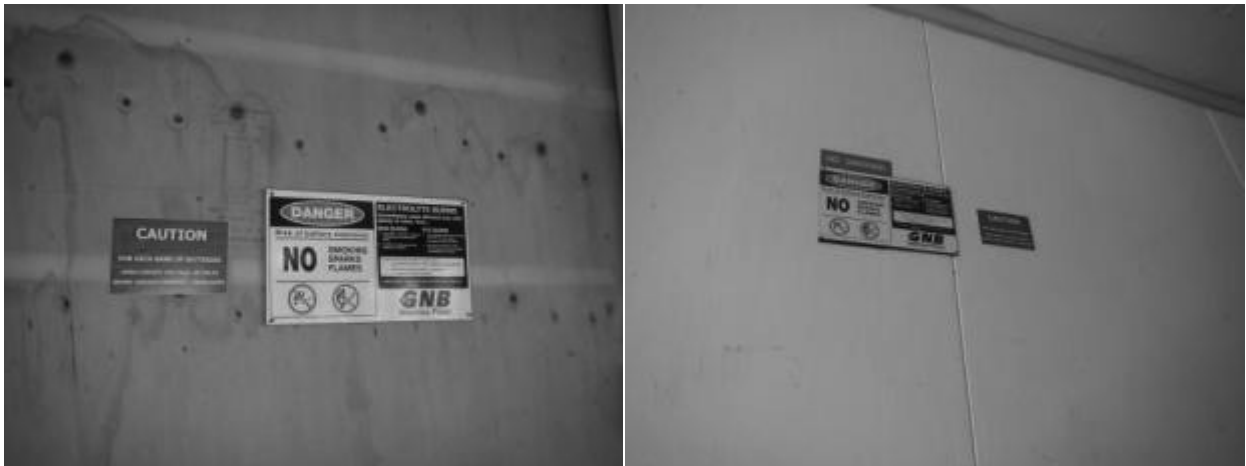
Appropriate warning labels were mounted on the walls at both ends of the battery room (Figure 26). Each battery was numbered and the cluster and string number was painted on the wall.

Figure 26: Warning labels at both ends of battery room

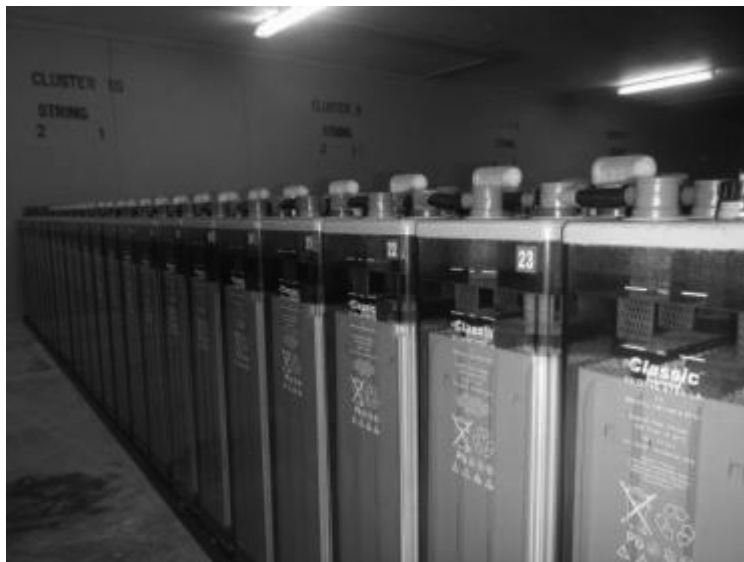
Figure 27: Labelling of clusters, strings and batteries

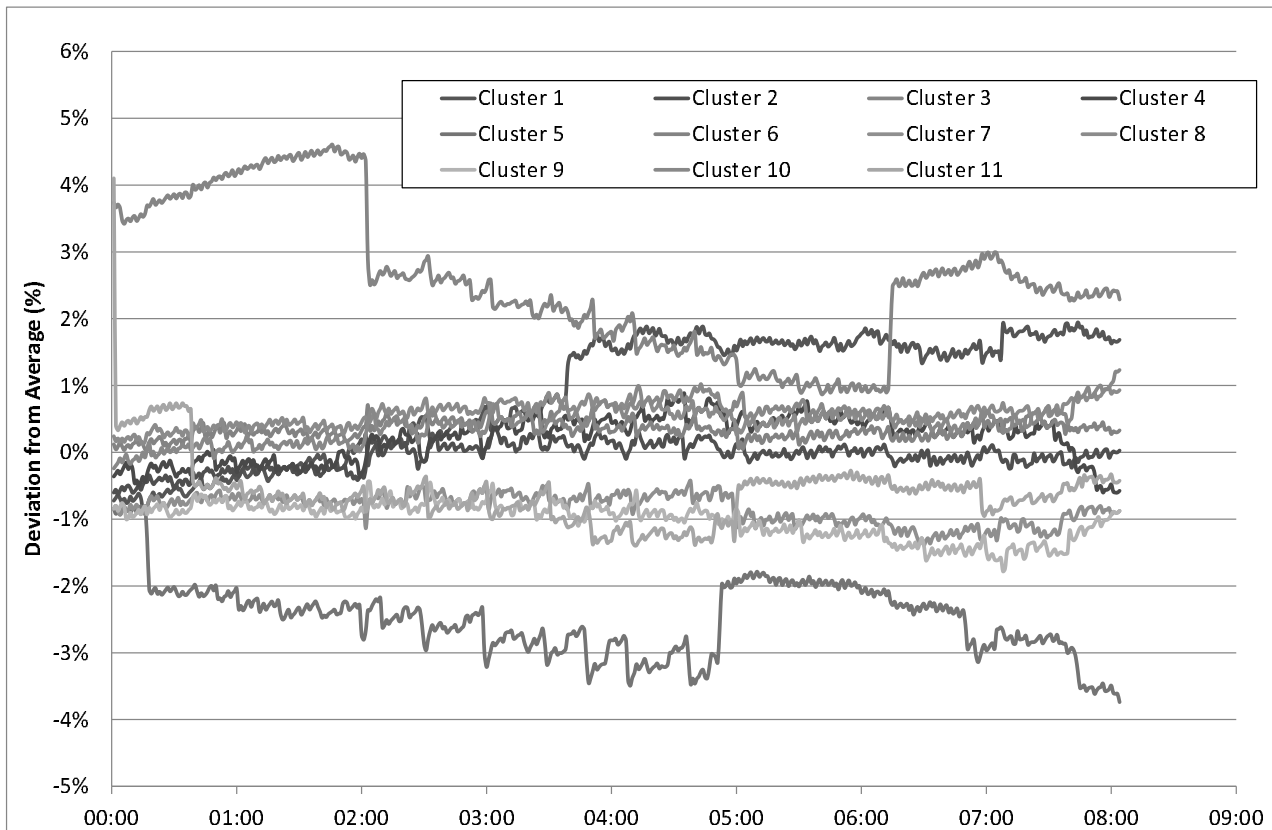
SOC data from the Sunny Islands was used to compare SOC across individual battery clusters. Each cluster was compared with the average SOC to find the deviation from the average throughout the day. Figure 28 shows the deviation from the average of each cluster. Note that sharp drops noticeable in the graph are a result of the Sunny Island's algorithm and do not reflect sudden actual drops in SOC. Cluster 3 is 1-4% higher throughout the day than the average, while Cluster 5 is 1-3% lower than the average. These deviations are small enough not to be considered problematic. The sudden step changes in SOC caused by the Sunny Island's algorithm may indicate that the method of calculating SOC is not ideal as it may make it more difficult for operators to identify deviations.

Figure 28: Percentage SOC deviation from average for individual battery clusters (04 June 2013)

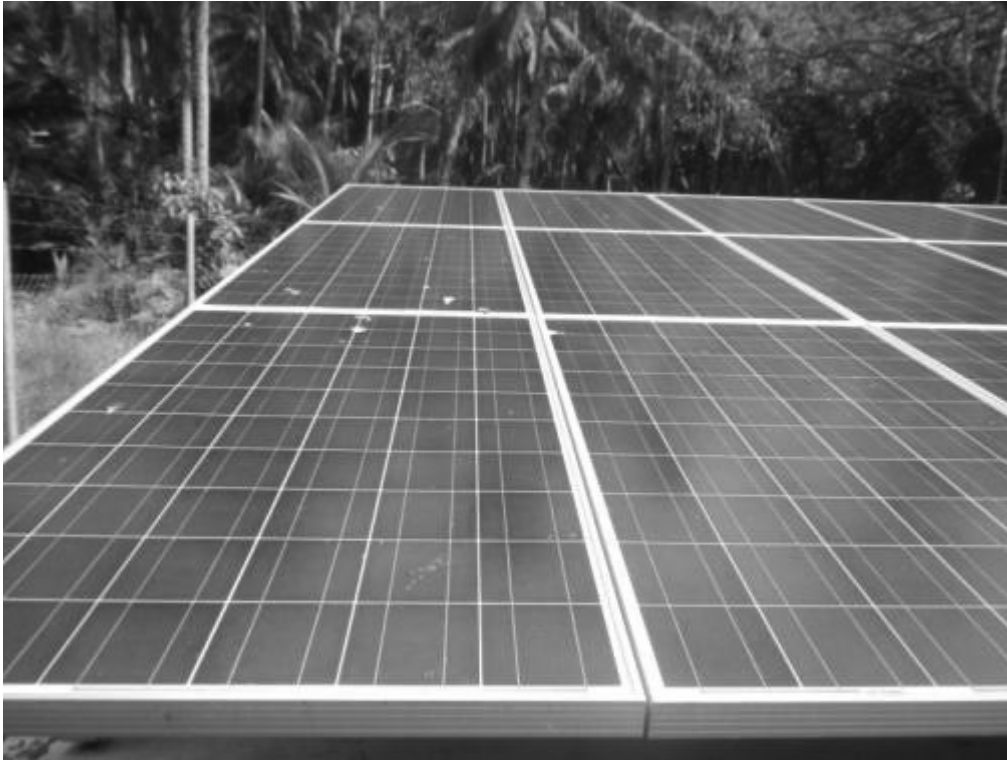
Overall the panels were clean and free from any signs of excessive build up of dirt or droppings. There were some bird droppings on the panels but these were not excessively stubborn and appear to wash off in rain storms.

Figure 29: Panels are mostly clean with the exception of some bird droppings

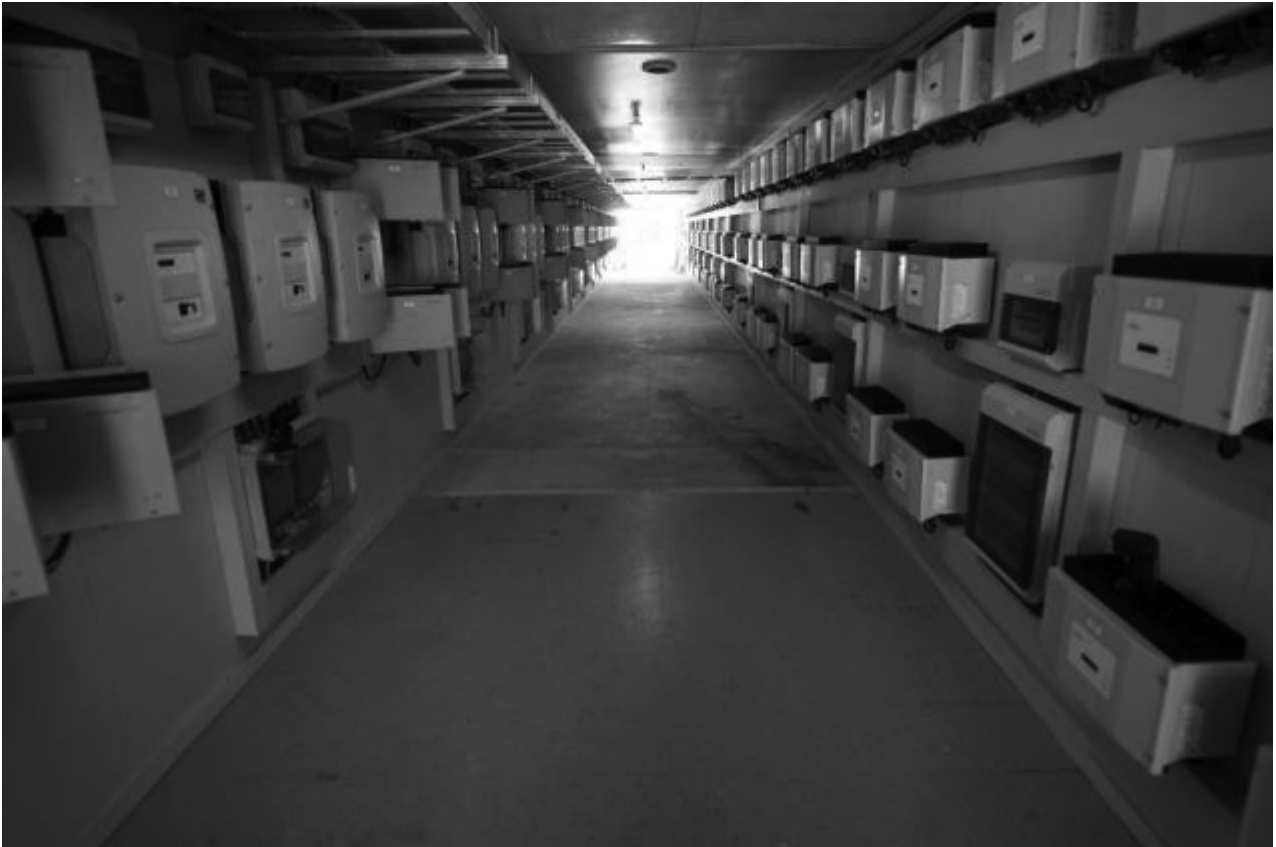
The inverter room was generally kept clean and tidy. There were no trip hazards or water in the room, and the tool box was stored under the operator desk where it could easily be found. The tool box was locked and all tools were present.

Figure 33: Inverter room

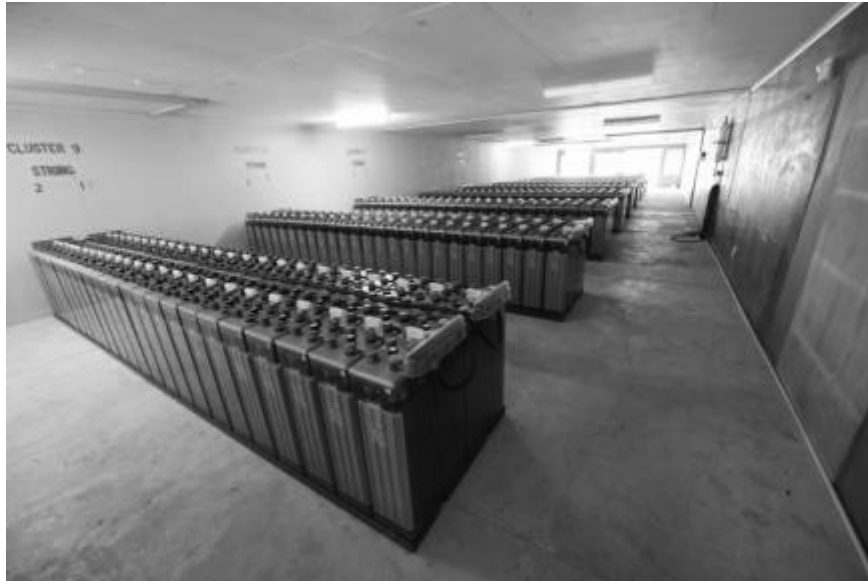
The battery room was generally clean and dry. One drum of battery acid had been left next to the batteries. Because of the size of the room this does not greatly obstruct access, but the drum should nonetheless be moved out of the way.

Figure 34: Battery room

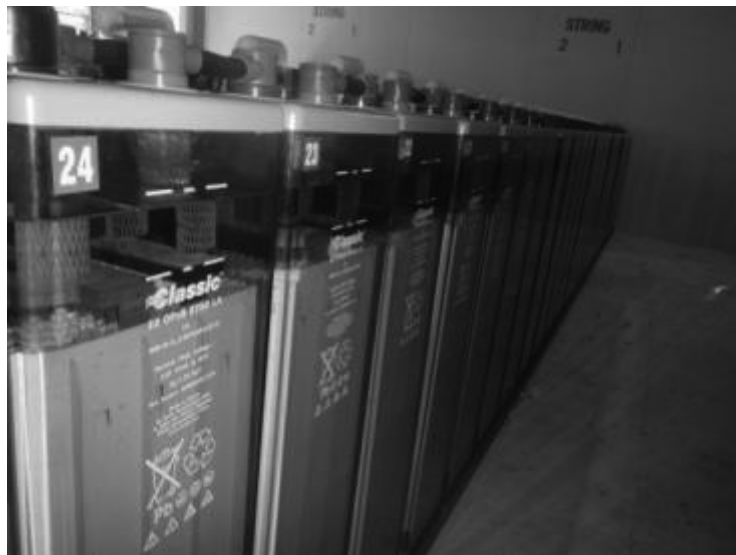
All battery electrolyte levels were close to the maximum line. Operators reported having topped up the battery electrolyte twice since the system was installed, and checking the electrolyte levels fortnightly.

Figure 36: Battery electrolyte levels close to maximum line

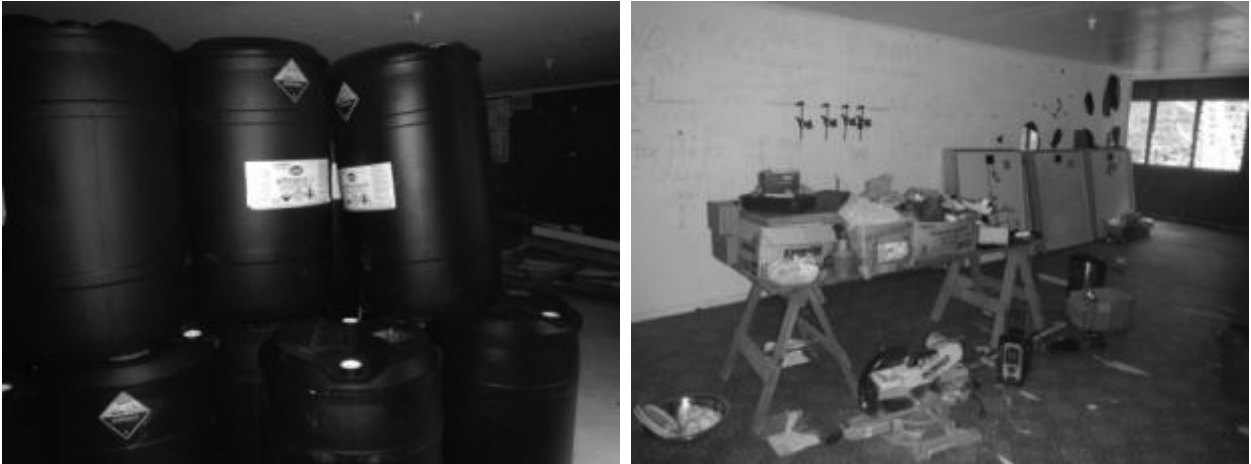
This is an appropriate spare parts inventory and there is no immediate risk of power station downtime due to lack of spares. All spare parts were kept indoors in a secure location, although general tidiness of the storage rooms could be improved.

Figure 37: Spare battery acid (left), panels and general tools (right)

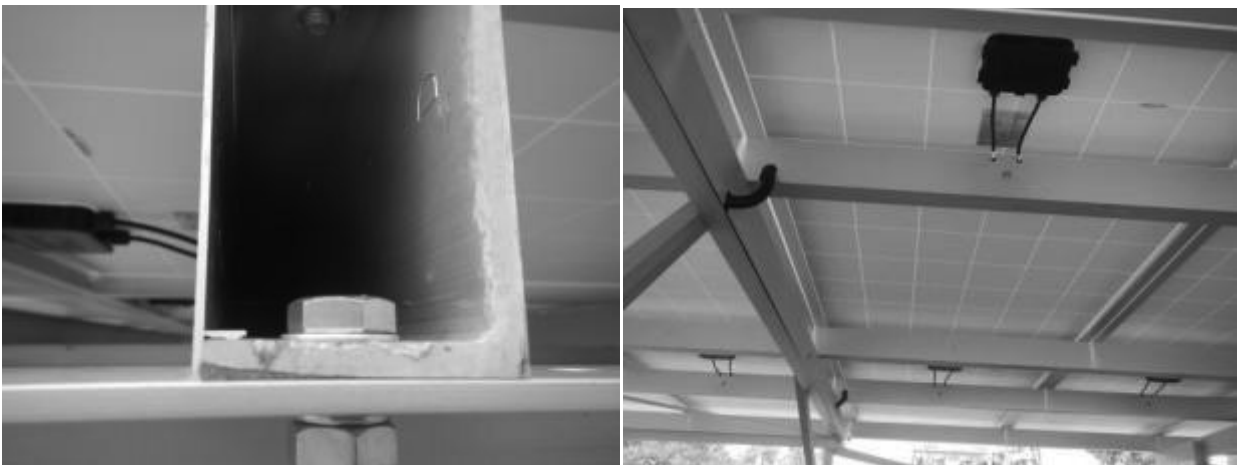
No signs of movement were observed, and none of the bolts randomly checked were loose. Figure 38 and Figure 40 show typical array frame details including bolts and general condition of the array frame. No structural problems were observed. Some small spot rust (“tea staining”) was observed on some of the bolts and small rust patches were found on the u-shackles used to support PVC conduit containing cables. Tea staining on stainless steel usually occurs around joints or edges (such as the lettering on the bolt shown) and is mainly a cosmetic issue unlikely to spread. Nonetheless, bolts should be checked regularly for any signs of more extensive rust. Rust spots on the u-shackles should also be checked regularly and these may need to be sprayed with an anti-rusting agent.

Figure 40: Array frame detail showing general framing and bolts

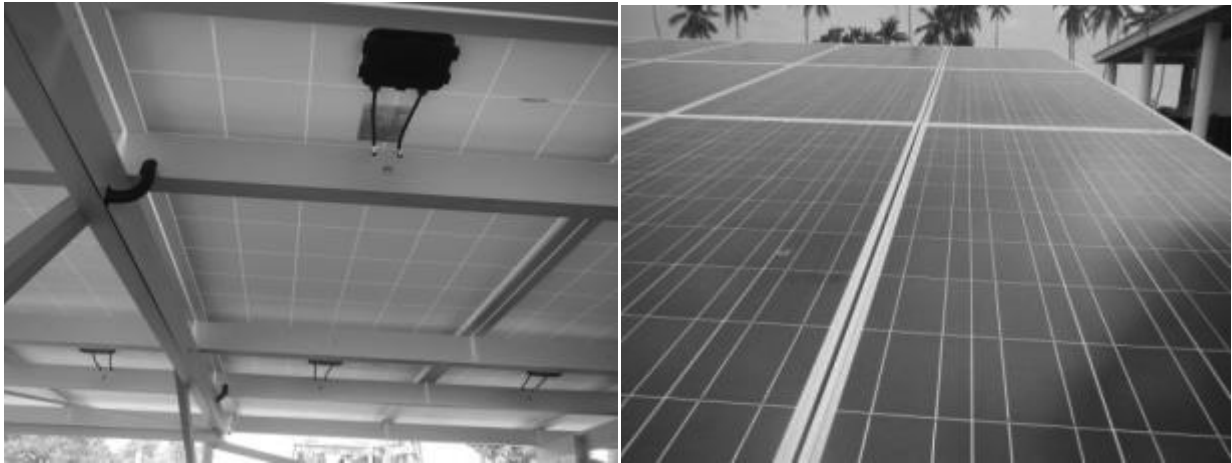
No signs of damage or hot spots were observed. Figure 42 shows typical panel front and back surface appearance. No dark spots, peeling or cracking were observed on any part of the array.

Figure 42: Typical condition of panels

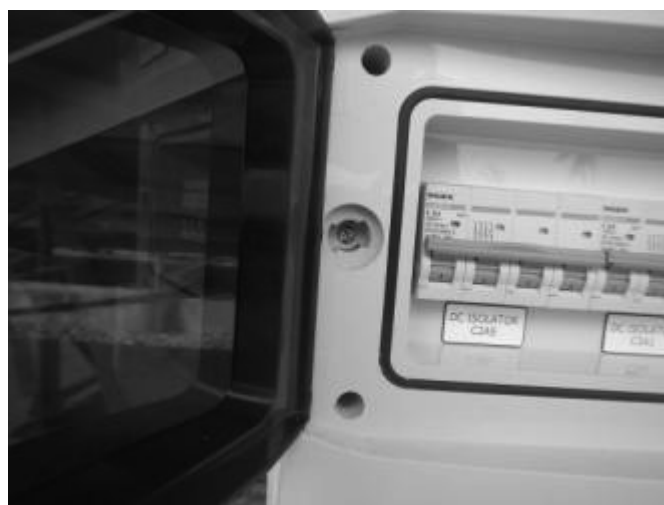
Very little insect infestation was found in the isolators and insects do not appear to be a problem at this site.

Figure 46: Isolators free from wasp nests

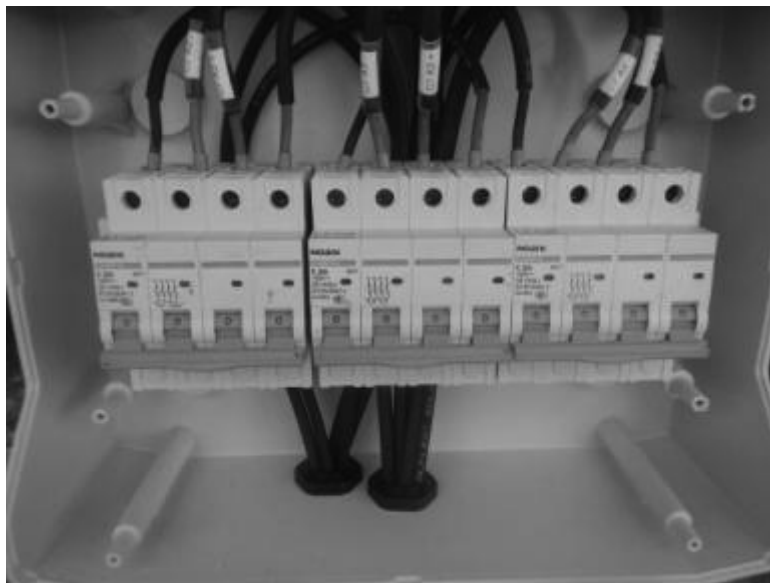
Isolator enclosures were clean and dry inside. There was no evidence of any previous water ingress. The enclosures are mounted under the array, giving them good protection from rain under most circumstances.

Figure 47: Isolators clean and dry inside with no loose cables

Cable terminations on the isolators were checked for any movement by wiggling them. No loose connections were found and there was no evidence of any cables having moved since installation. Cable terminations were appropriately done with no sign of exposed copper wire inside the enclosures (Figure 47).

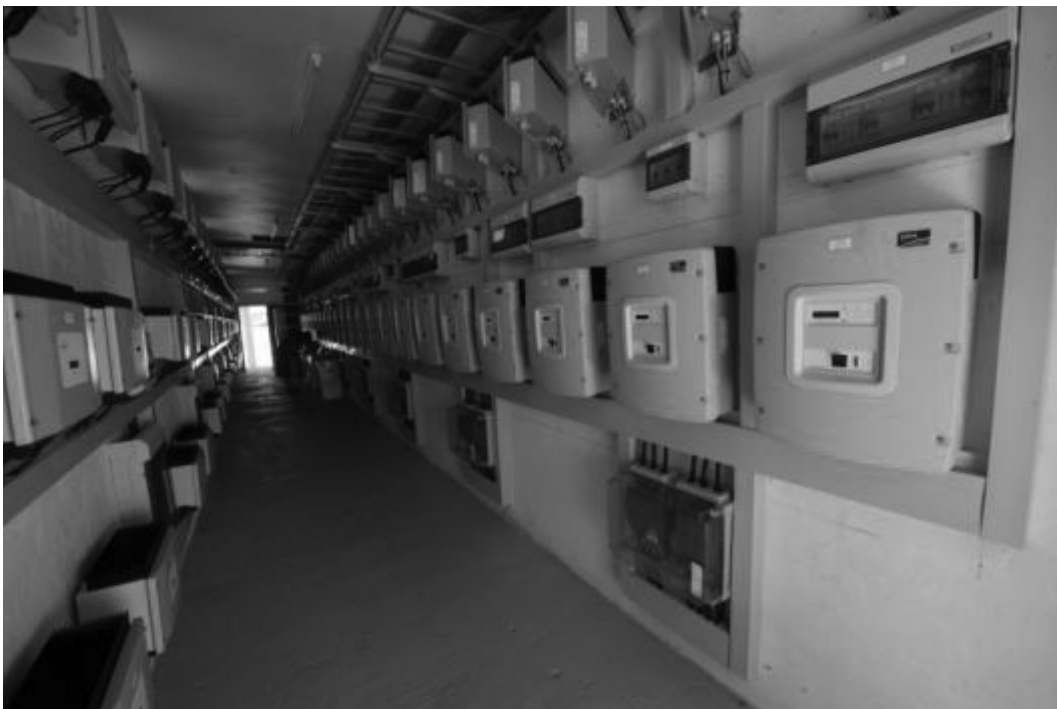
Temperature measurements ranged from 32°C to 33°C throughout the room. A measurement taken above an inverter heat sink read 35°C. Ambient temperature (outside in semi-shade) was 31°C. This indicates that the current ventilation scheme is suitable.

Figure 48: Naturally ventilated inverter room

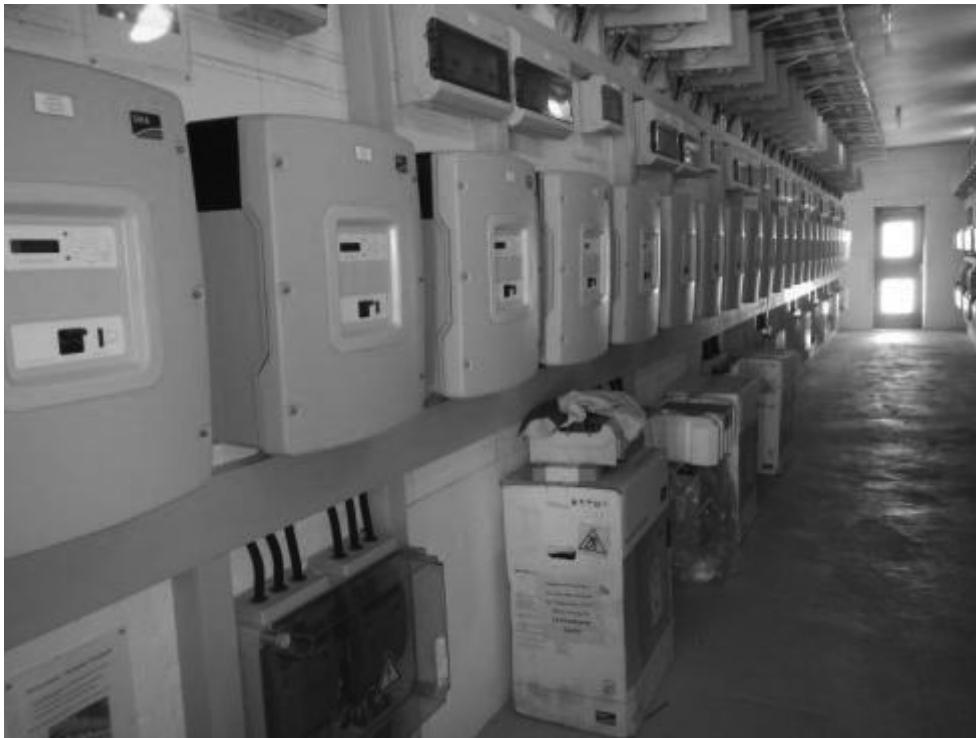
All inverters, Sunny Islands and chargers were operating normally at the time of the inspection.

Approximately a week before the inspection, the system had shut down after a lightning strike. Operators had initially thought that one of the Sunny Islands was damaged, however after troubleshooting with PowerSmart Solar and SMA, it was found that a communications board was damaged in Sunny Island Cluster 5 Slave 2. This was replaced with a new board and the system is fully functional again. All SD cards were present in the Sunny Islands.

Figure 49: Sunny Islands operating normally

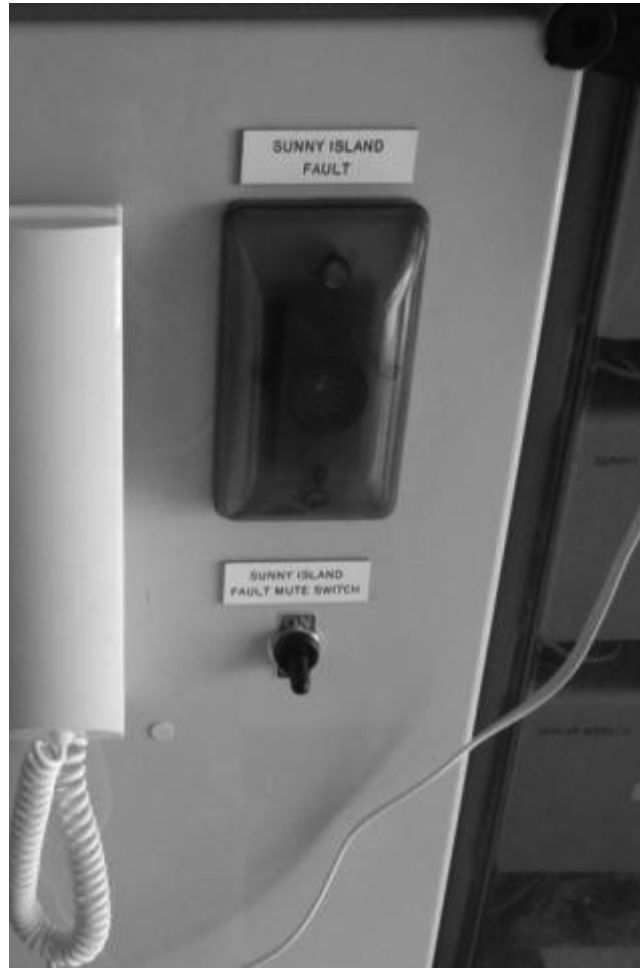
Operators reported no erroneous tripping. The Sunny Island Fault Mute Switch was in the “OFF” position.

Figure 50: Alarm mute switch in “OFF” position
